# Field Road/Coley District: Phase 3 Chalk Mine Ground Investigation and Ground Stabilisation Scheme

## Project Profile

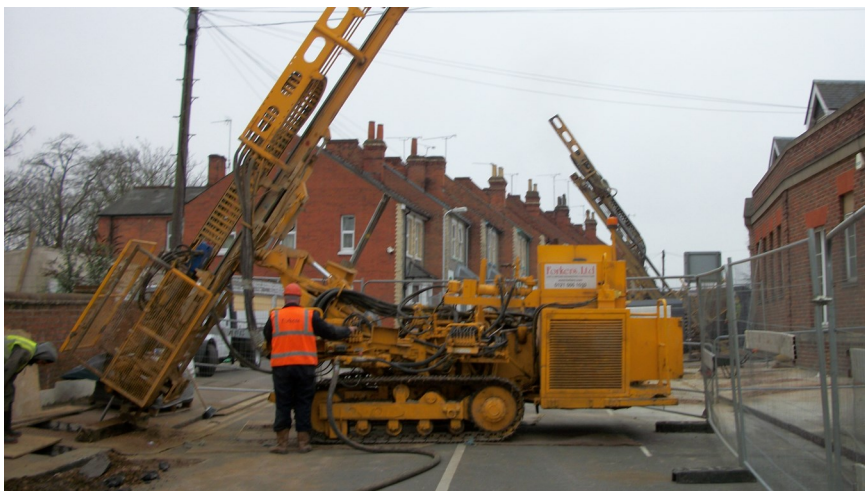
Interpretation of data from the previous investigations had identified at least 17 areas of workings and a priority investigation and treatment sequence was allocated by PBA to groups of properties or individual houses for this scheme. This drawing shows the location of investigation holes, and the results from these holes were analysed to enable design of the stabilisation solution which is bespoke to each property.
