## Bream Land Stabilisation, Forest of Dean, Gloucestershire Phases 1& 2

<b>Client:</b>	Gloucestershire County Council
<b>Engineer:</b>	Halcrow Consultants
<b>Value:</b>	£1.01m
<b>Date:</b>	Phase 2 Mar – Nov 2002 (Phase 1 -1999)

Infilling of abandoned and dangerous mines in the village of Bream, Forest of Dean.

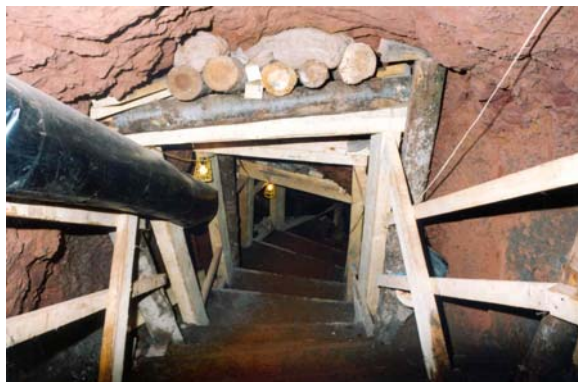
Access adit to Rough Winds Mine

This area required access to be made via an existing adit to the mine which was re-supported with timber frames. Continuous ventilation was required due to the recorded presence of (low levels of) radon. Personal monitors were carried to record exposure levels and working time was limited to 8 hours.

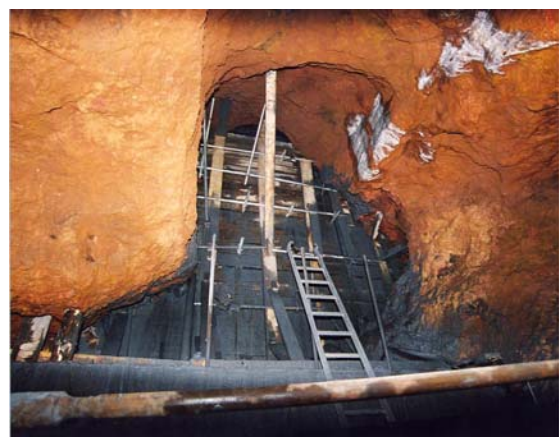
Shuttered barrier and grout infill area

Barriers to infill areas were created by using shuttering and filling with high strength grout. Barriers were stepped and raised in steps with 1.2m lifts, using dowls drilled in the previous step to key-in-and support the next step. Care was taken to prevent loss of grout into, or bursting of grout through discard by placing a geotextile membrane, onto the existing floor prior to grout filling.

Once the barriers had been completed and tied into the mine roof, the infilling of the (updip) galleries was carried out using PFA / cement grout (1700m<sup>3</sup>)

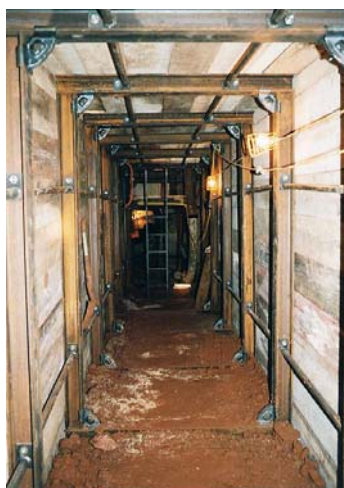
Permanent roadway through infilled mine

In addition a permanent roadway access was required to be left in place for drainage and future access and monitoring to other mine areas. This was provided by lining an existing 20m section of mine roadway with standard mine arches, with bulkhead walls at each end formed from in-situ concrete, together with a structural concrete surround. 250m<sup>3</sup> of high strength concrete was pumped underground for this work.

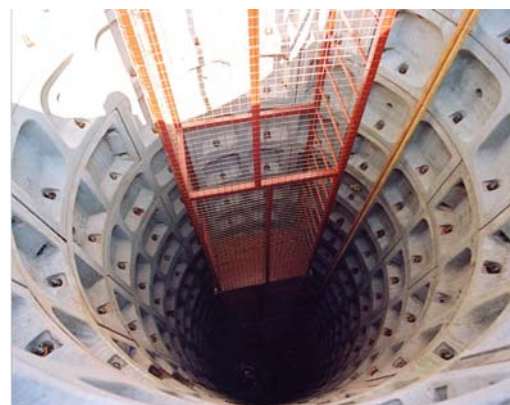
Access shaft to Brooklyn Mine

A new access was provided to the Brooklyn Mine by constructing an 18m deep x 2.4m diameter shaft onto a roadway area, which was constructed in the garden of the property overlying the mine. Once access was gained, topographical, geotechnical, environmental and radon surveys were carried out.

On completion of infilling works the shaft was fitted with permanent ladder access and cover slab.
