## Bridgnorth Road UID, Wolverhampton

**Client: Severn Trent Water**  
**Designer: Severn Trent (in-house)**  
**Value: £1.5m**  
**Date: 2010/11**

This UID project was undertaken to replace an underperforming CSO in the Compton area of Wolverhampton that was spilling foul flow to the adjacent Smestow Brook up to 50 times annually and was designed to intercept the existing spill pipe from the main sewer, store the first flush and then return it to the foul water system when flow conditions subside.

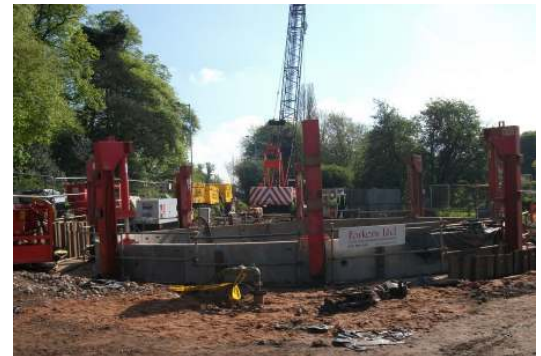
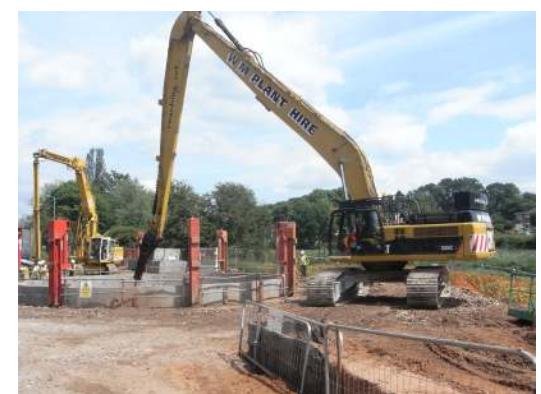
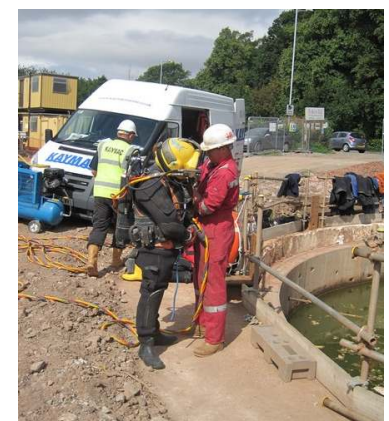
Shaft sinking continued using an excavator with extending dipper and hydraulic grab and had reached a depth of 12m depth but was halted when a band of hard sandstone was encountered which could not be excavated with the grab. The position, angle and thickness of the rock band was confirmed by divers who were able to probe round the cutting edge and by probe drilling around the shaft perimeter which proved that the sandstone band was dipping and was up to 2m thick.

A 45 tonne, long reach excavator with breaker attachment was resourced to site to attempt to break out this rock in the shaft to allow shaft sinking to progress, however the operator could only work 'blind' due to the depth of silty water in the shaft. Some success was achieved and the combination of breaker and grab enabled sinking a further 1m however inspection of the steel cutting edge by divers revealed that it had been damaged and buckled, either by the breaker or possibly by pushing the shaft over a remaining hard nib of rock. Following this it was accepted that it would be impossible to continue sinking the shaft without significant risk of damage.

In order to maximise the storage capacity of the shaft/pumping station it was necessary to minimise the base plug and base slab thickness. We were able to complete a vertically drilled compaction grouting exercise around the shaft perimeter in order to maximise the skin friction around the shaft to resist uplift which allowed the thickness of the base plug to be reduced substantially. These external grout holes were drilled to full depth and a mortar grout injected in

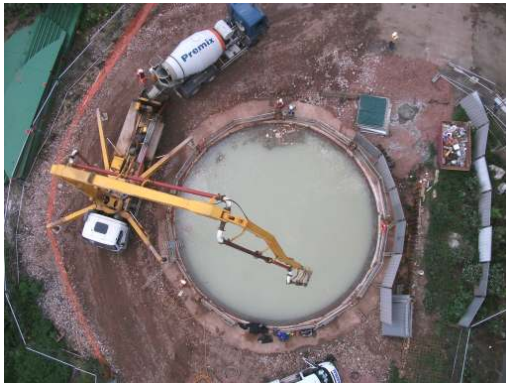
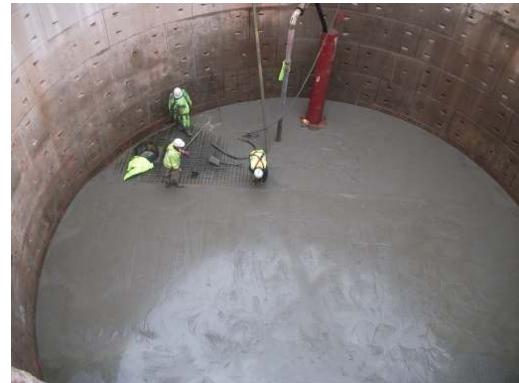
The shaft base plug was poured with the assistance of divers to place the non-wash out concrete mix.

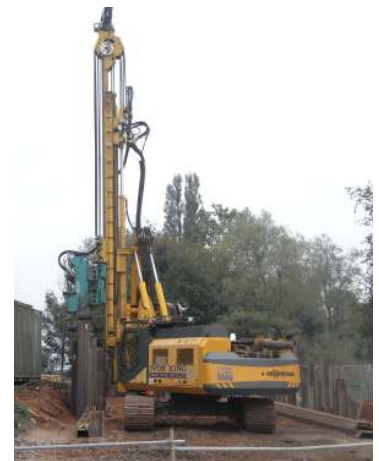
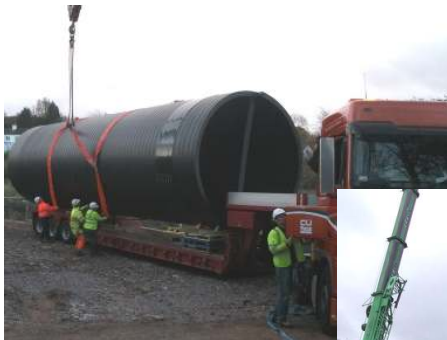
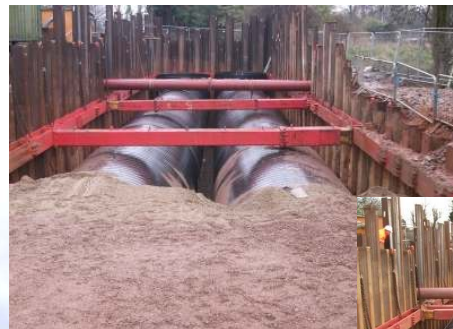
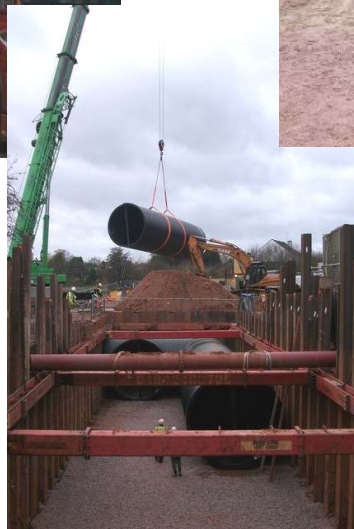
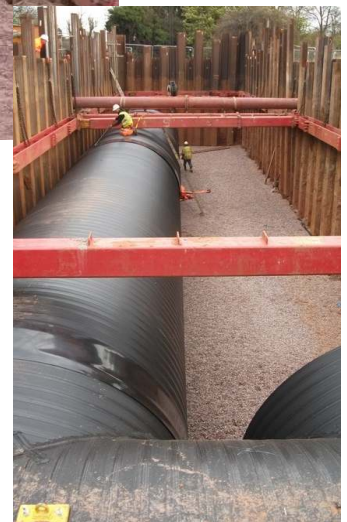
A review of the scheme design requirements was carried out with Severn Trent and it was agreed that the remainder of the storage volume was still required in order to complete the EA agreed solution. We considered a number a storage solutions however decided to proceed with a pipe storage tank system consisting of 100m of 3.5m diameter Asset Weholite pipes placed adjacent to the shaft to provide the additional 950m<sup>3</sup> of storage required. The pipes were constructed in 3 legs with a connecting manifold to suit the available working area.

Due to the wet sand and gravel strata present a sheet piled cofferdam was constructed for the Weholite tank to allow the necessary internal excavated depth of 6m to be achieved.

The 3.5m diameter pipes were surrounded in lean mix concrete to ensure stability against flotation and movement under the high water table and to cater for the risk of a traffic accident which would potentially damage the shallow pipes if an HGV vehicle ran off the adjacent trunk road.
