## Drake Gardens Lead Mine Stabilisation, Tavistock, Devon

**Client:** West Devon Council  
**Designer:** Hyder Consulting  
**Project Manager:** Cyril Sweet  
**Value:** £1.0m  
**Date:** November 2010 – July 2011

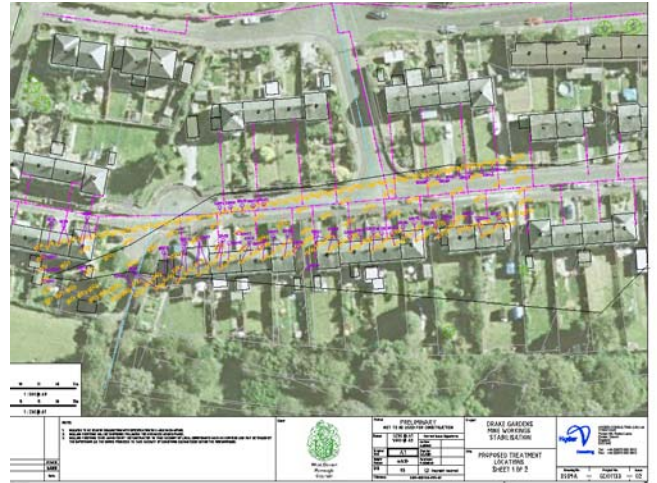
The Lead seam or 'Lode' was conjectured to have been worked between 1857 & 1874. Some 14 properties were affected by the shallow workings which had caused settlement, minor damage and evacuation of some of the properties. The lode dips at approximately 60° deepening eastwards against the topography and was mined from a series of adits driven horizontally along the lode at depths of 22, 44, 73 and 95m. The site is overlain by 5 to 7m of river terrace deposits beneath which is a soft slate within which the lead lode has been formed. The sub-crop of the lode runs close to or under several properties on the West side of Drake Gardens resulting in the risk of void migration to the surface.

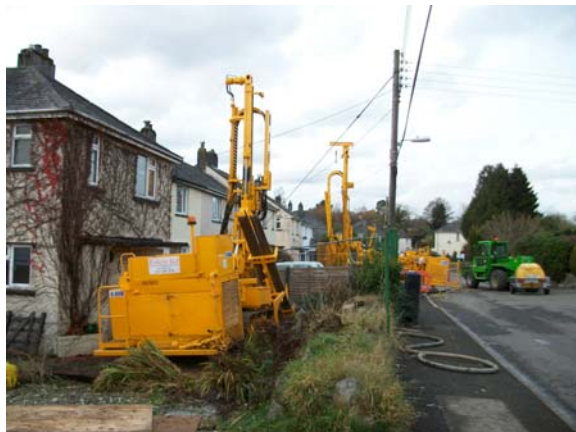
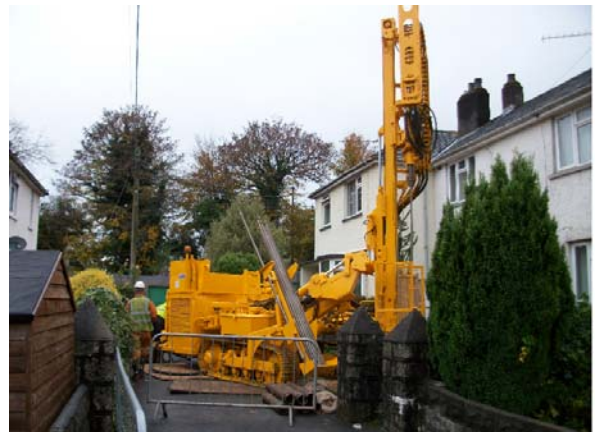
- **Phase 1 Site Investigation (Nov – Dec 2010).** A range of intrusive investigation work was completed to confirm the extent and condition of the lead mine workings beneath highway, gardens and the 14 residential properties using rotary probing, dynamic probing, and trial pits. Investigations also focussed on location of a main access adit and 3 mineshafts. Both standard geotechnical drilling rigs and mini-rigs were used depending on drill hole positions and access restrictions. Down-hole ultrasonic cavity surveys were undertaken to obtain data on the size of any significant voids that were located. The investigation phase also included a grouting trial to prove the proposed stabilisation methodology.

The investigation proved that although there were no major voids there was significant micro voiding of the soft and loose material filling the mined lode and stabilisation work involved treating this very soft material.

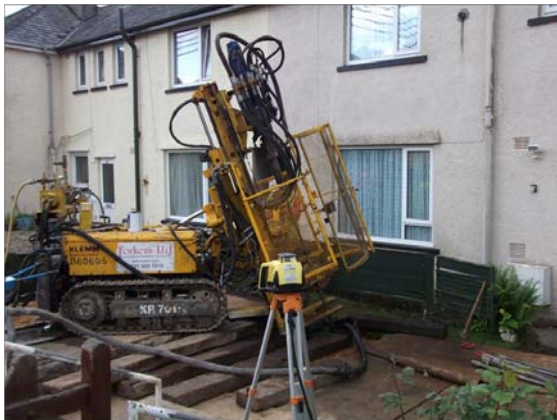
- Phase 2 Treatment (March – June 2011).** Treatment involved stabilisation of the upper 25m of the steeply dipping lead workings by drilling and grouting under the affected properties with a close grid of boreholes and using a compaction grouting methodology to treat the broken and collapsed ground. 300 treatment holes were completed starting with a 3m perimeter line along the down-dip edge of the treatment grid, and 450m<sup>3</sup> of grout injected. Much of the treatment phase drilling required angled holes to treat under the properties and due to the confined nature of the site with drilling carried out from gardens, driveways and the cul-de-sac outside the properties versatile Klemm KR 904 Geotechnical drilling rigs and Klemm 701 mini-rigs were used.

Grout mixing was carried out remote from the properties in the site compound at the northern end of the site. The grout mix of sand, cement and bentonite was used to produce a stiff but pumpable grout mix for the compaction grouting stabilisation process. Mixed grout was pumped to the treatment holes using staged 4m<sup>3</sup>/hr screed pumps. Stabilisation started in the south of the site and worked towards the north, with validation test holes following on behind. Grout flow and pressure gauging equipment allowed continuously monitoring of grouting at each borehole with information being transferred to a datalogging system. This data was fed into a Rockworks 3D modelling software programme to map the real time progress of the stabilisation work .
