Niddrie Burn Restoration—Mine Consolidation Treatment

Client: Edinburgh City Council

Designer: Jacobs

Date: April—July 2011

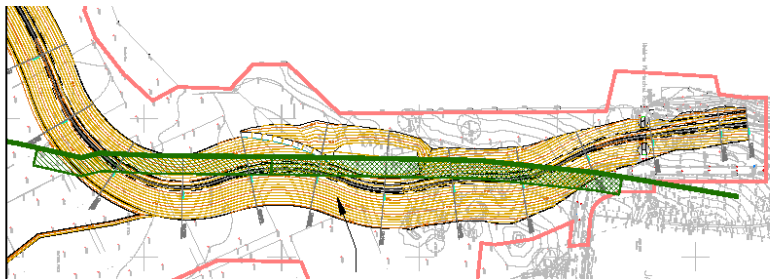
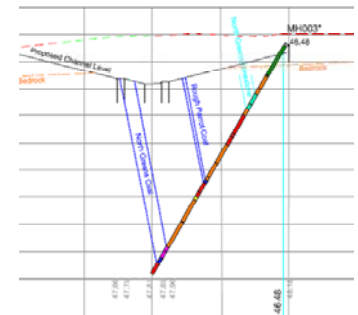
The preliminary site investigation work and old mine plans suggested that the steeply dipping (80°) 1.7m thick North Greens coal seam lay beneath part of the proposed realignment route and may have been extensively worked but the full extent of these workings was unclear. Therefore the initial phase of the contract involved further investigation by probe drilling on a series of grid lines perpendicular to the seam, spaced 45m apart, to establish the exact position of the seam as well as the extent and condition of the workings. 85 probe holes were drilled to approximately 50m depth along the 500m section of the site thought to be affected by the workings. Two Casagrande C6 drill rigs were employed during this phase of the work using rotary percussive drilling techniques with water flush. Results from these probe holes allowed Jacobs to complete the stabilisation design.

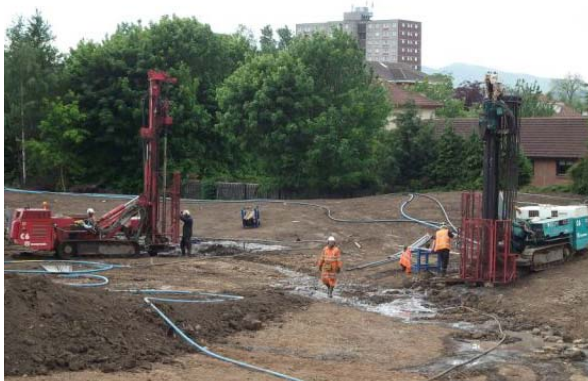
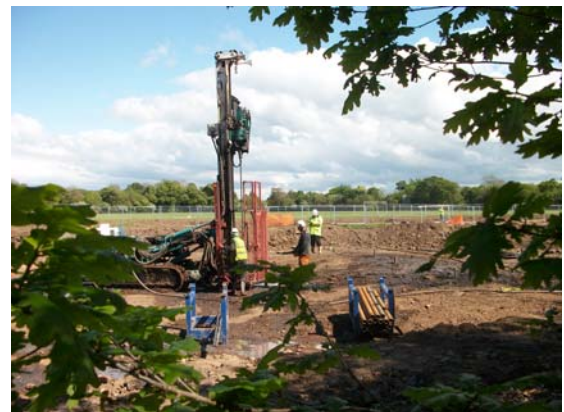
The seam dip, treatment depth of up to 50m and the nature of collapse migration meant that treatment could not be carried out with conventional grout tremmie insertion. Our proposed methodology was to drill and case the grout injection holes to full depth at the 80° angle of the seam using 88.9mm dia rotary percussive casing. The drilled casing was then used as the grout injection tube and the seam grouted in 2m ascending stages. 4 Casagrande C6 drill rigs were used during the treatment phase with each rig supported by a grout injection team.

Over 300 grout holes of between 40 and 50m depth were drilled along the seam in a primary, secondary and test hole sequence and 2000t of 12:1 pfa/cement grout used in the consolidation works.

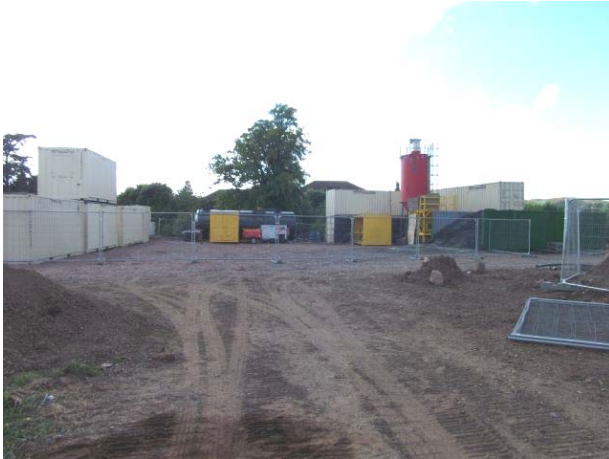
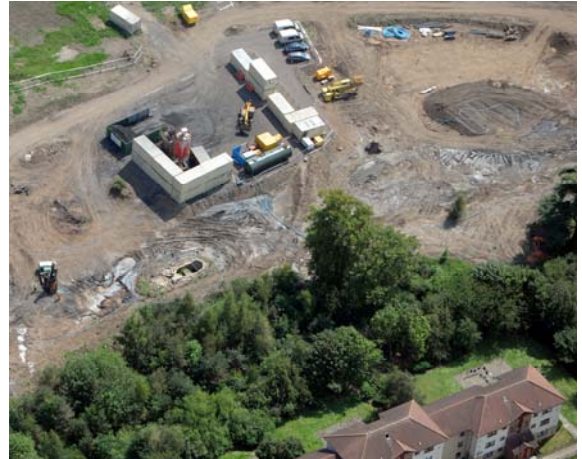
The site compound establishment included a container surrounded pfa storage area and grout mixing area. The containers, set 2 high, provided PFA bunkering but also worksite screening and noise & dust attenuation to the adjacent residential property. Cement was stored in a 30tonne silo.
