## Northern Gallery Access Works & Seven Sisters Temporary Stone Infill

<b>Client:</b>	Dudley MBC
<b>Value:</b>	£770k
<b>Date:</b>	2003/2004
<b>Type of Mine:</b>	Limestone

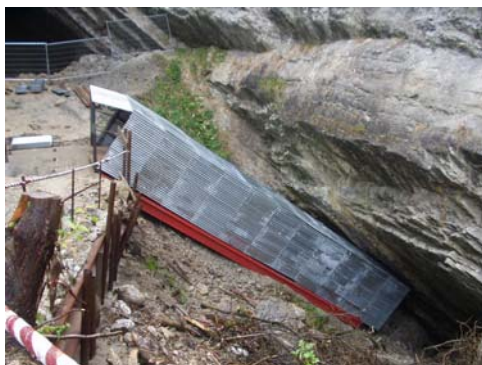
Tunnel portal section prior to filling over

An anchored concrete working platform was constructed outside the potential area of collapse risk and guide rails lowered into the mouth of the gallery up to 38° angle of dip. This allowed sections of pre-fabricated steel tunnel to be lowered or 'slid' into the gallery.

Once this "outer" portal section of the tunnel was in place it was surrounded in concrete and then imported dolerite stone was placed over the tunnel and filled against the face of the exposed work face to provide stability and protection.

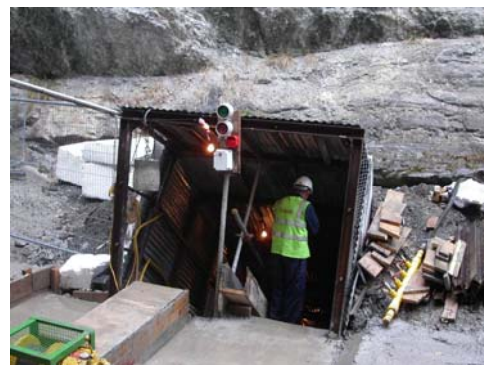
View of tunnel portal

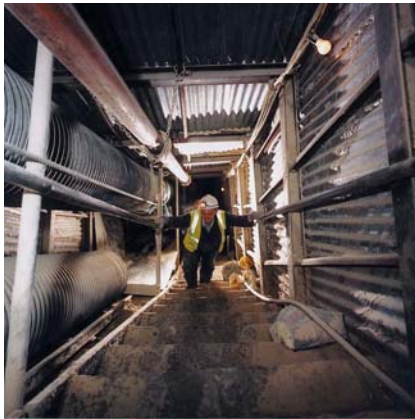
View down completed tunnel

Once portal works were completed the new tunnel was driven through collapsed and backfilled material into the Northern Gallery finished at the top of the scree pile. A bulkhead wall was formed around the end of the tunnel and the tunnel surrounded in concrete.

The tunnel is 40m long and driven down dip at an angle of 38°. Frames were set at 1.2m and bolted to the mine roof.

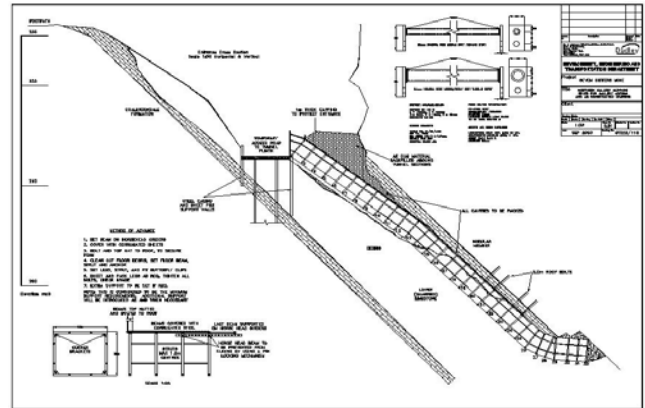
Section through tunnel

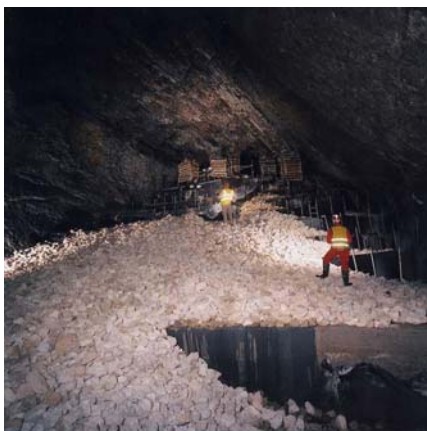
Northern Gallery showing supported working platform, barrier steps, and infilled limestone.

Following completion of the tunnel, a working platform was constructed at the top of the gallery and the immediate gallery roof area protected with timbering and 'cogging'.

A barrier structure was then completed in the gallery to prevent infilling paste migrating from the Severn Sisters Gallery into the Northern Gallery area. The barrier, partially constructed against existing scree fill and partial in open upper areas was constructed in 13 steps over a height of 18m using 350m<sup>3</sup> of foam concrete pumped into the mine from surface. Geotextile was used to prevent loss of foam concrete into the scree.

In order for the gallery to be fully utilized for a bat habitat, 600 tonnes of 150mm Jurassic limestone was imported and placed randomly down the slope of the gallery floor. To get this material into the gallery, a drop pipe and chute arrangement was constructed down the new tunnel, loaded by conveyor. This work was carried out in close liaison with Bat specialist – Dr Robert Stebbings Consultancy.

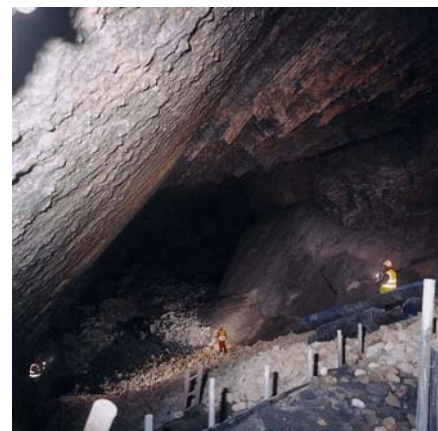
View of Northern Gallery from working platform

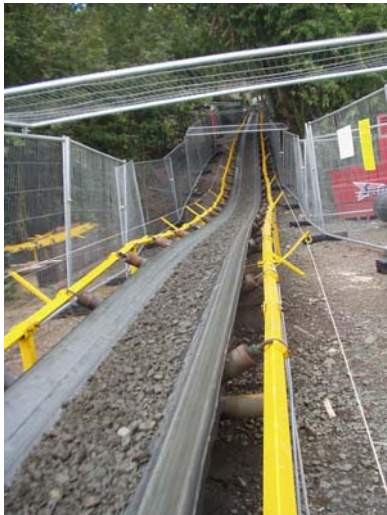
Primary Conveyor

An 80m long 65hp primary conveyor with 42” belt running from the compound area fed a 30m long secondary conveyor running parallel to the mine entrances. A series of 4 bridge belts between 6 and 15m long fed the stone into the gallery.

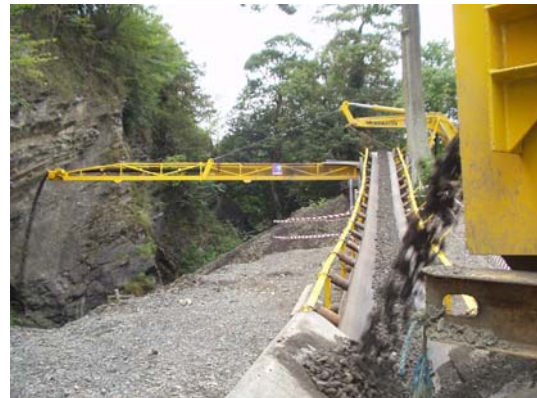
Secondary belt with bridge belt

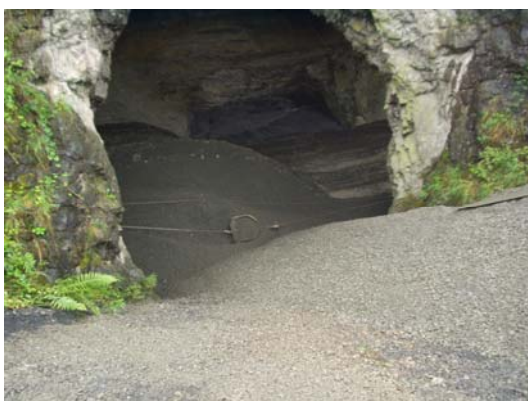
‘Slusher’ distributing infill stone

Once in the mine, the stone was distributed and stored using a Joy-continuous miner “slusher” dragline type unit. The unit was resourced with 2 x 200m ropes allowing the drive and return units to be set up outside the high risk zone.

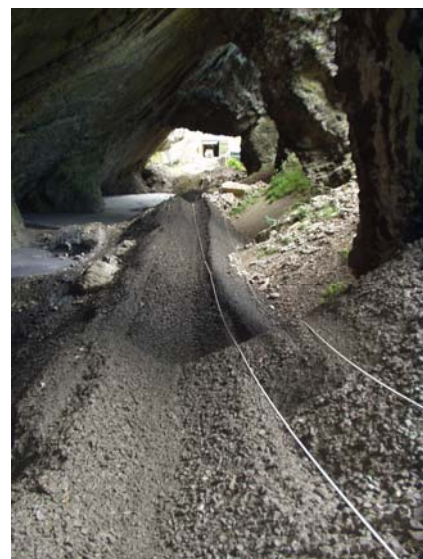
View through gallery at start of stone infilling
