Investigation and Treatment of Mine Workings Beneath Reinstated Opencast at Blindwells, Tranent.

Project Profile

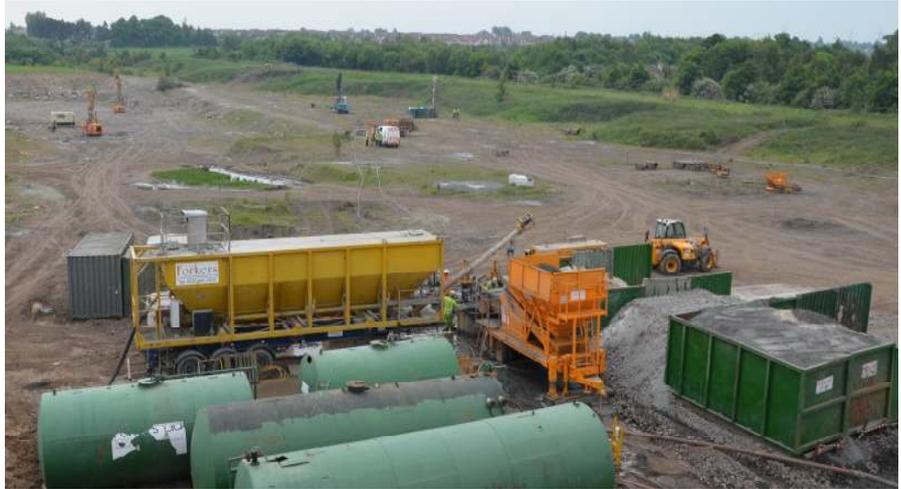
Within the footprint of the mine (red & grey areas) rotary percussive investigation boreholes were drilled on a 24m grid to confirm the thickness of overburden and the depth, thickness and condition of the shallow coal seams assumed in the initial design. Once design parameters had been confirmed, the areas requiring treatment were drilled and grouted on a 5m domino grid. Secondary and tertiary treatment holes were instructed based on primary hole grout takes.

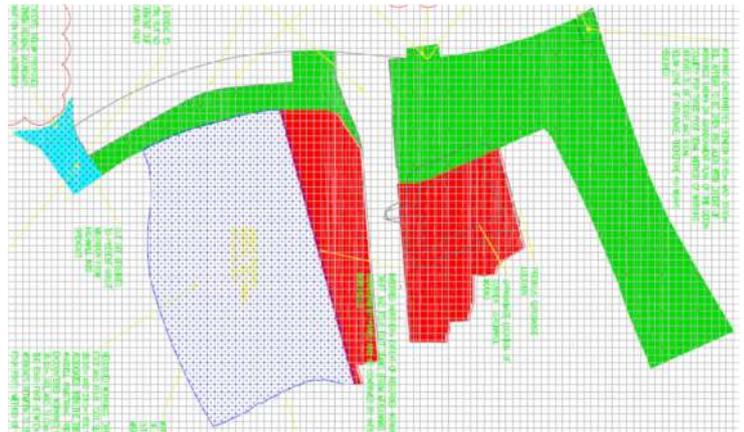
Grout batching and pumping was undertaken from a strategically located compound within the development area using 50m³/hr continuous grout mixer with grout pumped directly to the treatment areas. Container bunkering was provided for PFA and sand storage with 50t horizontal silo for cement and 4 large water storage tanks to supply grout mixing requirements.
