Bridgnorth Road UID, Wolverhampton

Client: Severn Trent Water
Designer: Severn Trent (in-house)
Value: £1.5m
Date: 2010/11

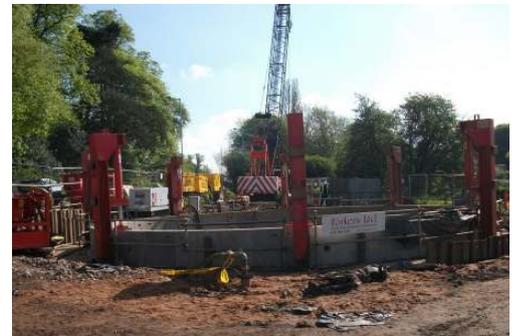
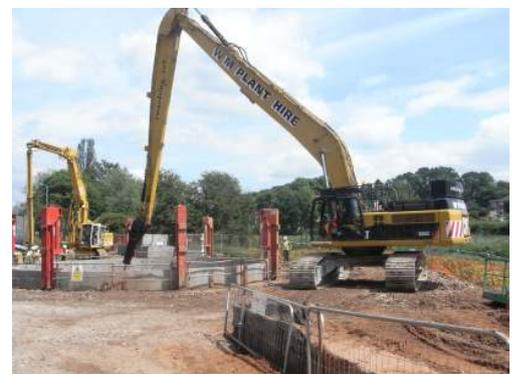
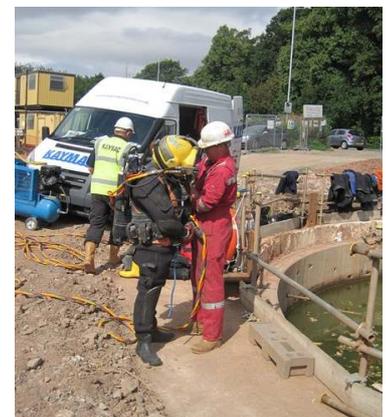
Shaft sinking continued using an excavator with extending hydraulic grab and had reached a depth of 12m but was halted when a band of hard sandstone was encountered which could not be excavated with the grab. The position, angle and thickness of the rock band was confirmed by divers who were able to probe round the cutting edge and by probe drilling around the shaft perimeter which proved that the sandstone band was dipping and was up to 2m thick.

A 45 tonne, long reach excavator with breaker attachment was resourced to site to attempt to break out this rock in the shaft to allow shaft sinking to progress, however the operator could only work 'blind' due to the depth of silty water in the shaft. Some success was achieved and the combination of breaker and grab enabled sinking a further 1m however inspection of the steel cutting edge by divers revealed that it been damaged and buckled, either by the breaker or possibly by pushing the shaft over a remaining hard nib of rock. Following this it was accepted that it would be impossible to continue sinking the shaft without significant risk of damage.

In order to maximise the storage capacity of the shaft/pumping station it was necessary to minimise the base plug and base slab thickness. We were able to complete a vertically drilled compaction grouting exercise around the shaft perimeter in order to maximise the skin friction around the shaft to resist uplift which allowed the thickness of the base plug to be reduced substantially. These external grout holes were drilled to full depth and a mortar grout injected in ascending stages to displace the soft sand and silt around the shaft perimeter.

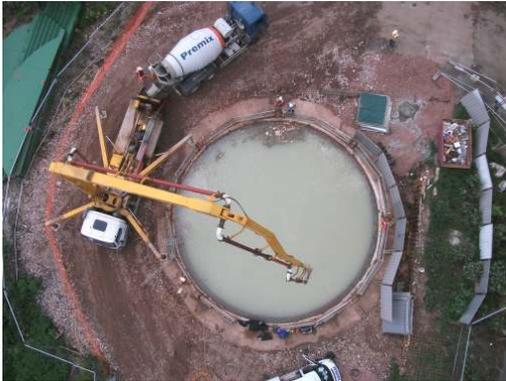
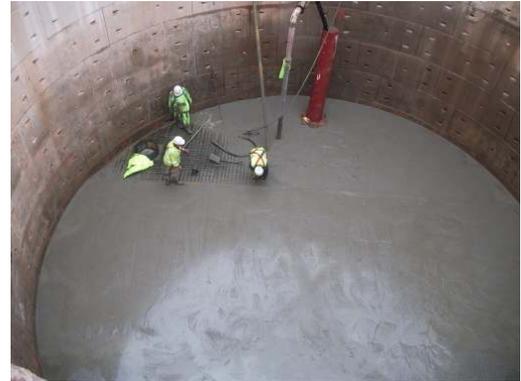
The shaft base plug was poured with the assistance of divers to place the non-wash out concrete mix.

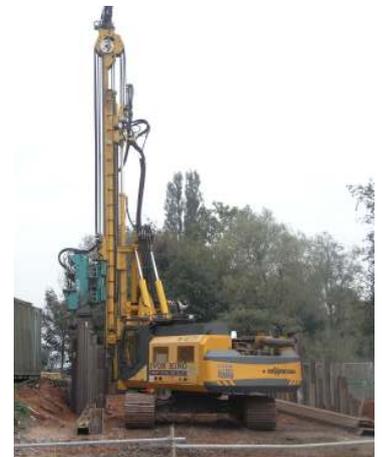
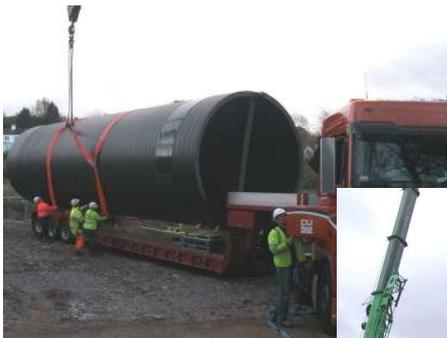
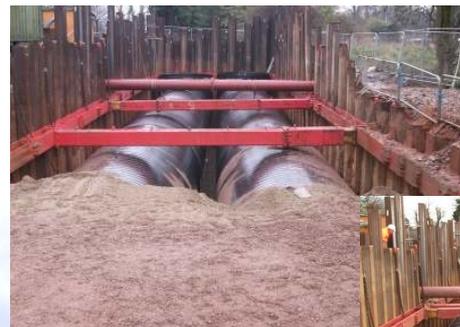
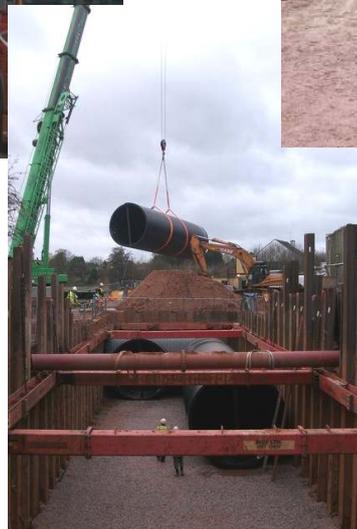
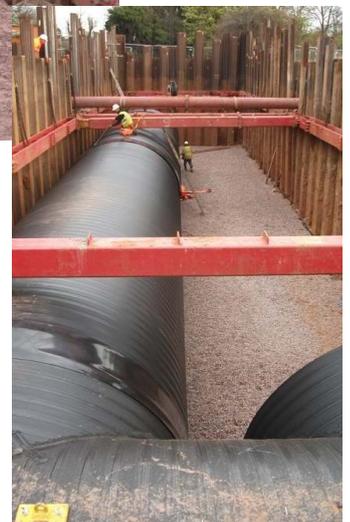
A review of the scheme design requirements was carried out with Severn Trent and it was agreed that the remainder of the storage volume was still required in order to complete the EA agreed solution. We considered a number a storage solutions however decided to proceed with a pipe storage tank system consisting of 100m of 3.5m diameter Asset Weholite pipes placed adjacent to the shaft to provide the additional 950m³ of storage required. The pipes were constructed in 3 legs with a connecting manifold to suit the available working area.

Due to the wet sand and gravel strata present a sheet piled cofferdam was constructed for the Weholite tank to allow the necessary internal excavated depth of 6m to be achieved.

The 3.5m diameter pipes were surrounded in lean mix concrete to ensure stability against flotation and movement under the high water table and to cater for the risk of a traffic accident which would potentially damage the shallow pipes if an HGV vehicle ran off the adjacent trunk road.
