## Castle Mill Canal Basin Rock Face Stabilisation

**Client:** Dudley Metropolitan Borough Council  
**Designers:** Geo-design & ASC Consultants  
**Date:** May to August 2011  
**Value:** £330k

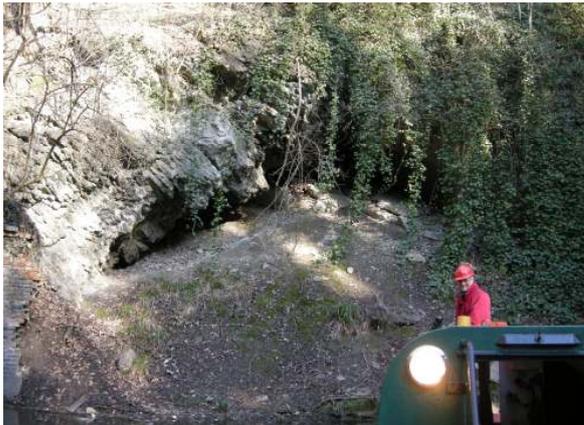
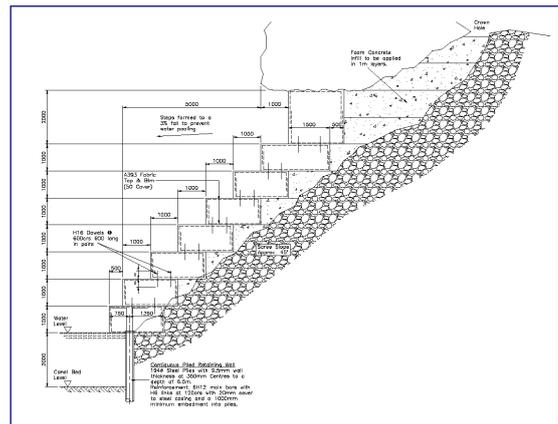
The canal basin at Castle Mill which was once part of an underground limestone mine gallery which has subsequently collapsed, is the junction of 4 canal tunnels and today forms part of the Dudley Canal Trust tourist canal trip through the Dudley limestone mine caverns. A partially filled mine gallery in the Lower Wenlock Limestone, once accessed by the canal system, also remains on one side of the basin. The unsupported and degrading rock roof at the mouth of the gallery together with the unstable scree pile at the gallery entrance caused as a result of crown hole development in the gallery roof had both been assessed as dangerous by Dudley's Mines Manager and requiring urgent remedial support works.

We were approached by Dudley MBC to look at solutions to the problem, in particular the difficult location, access restrictions and safety issues during the work. We worked closely with Dudley Council Geotechnical Engineers, consultants Geo-Design and the Mines Manager to develop a robust support solution and working methods which did not involve draining the canal or disturbance of the scree pile and also allowed sufficient space to be retained for the canal boat trips to continue operating during the work.

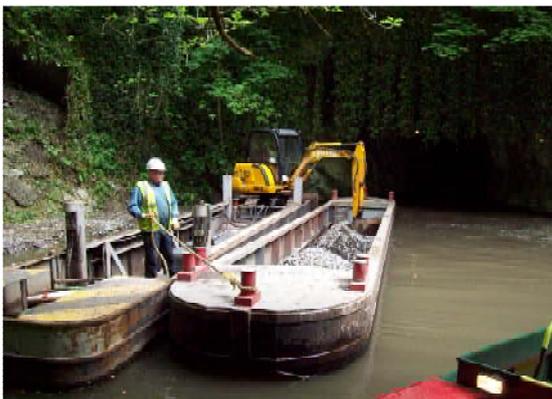
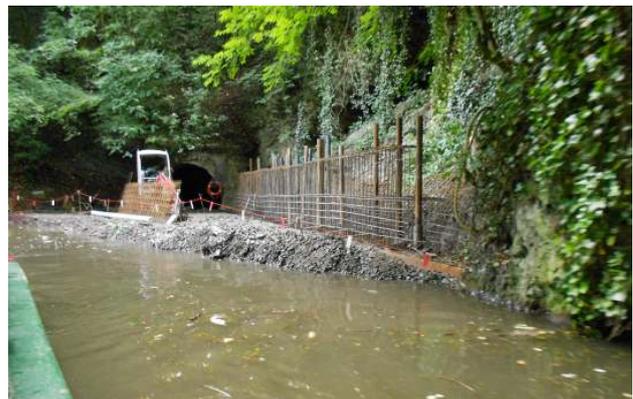
The design was based on constructing a stepped retaining wall structure formed from reinforced cement grout which was dowelled in to the rock face at the edges and crown of the gallery mouth. The retaining structure was supported on steel piles drilled by mini-rig into the bedrock at the edge of the canal from a narrow stone berm that was installed as a permanent feature and also used as a working platform so that the first step of the retaining wall was above canal water level. On completion of the retaining wall, the scree pile behind the wall was also pressure grouted to improve its stability and load bearing capacity.

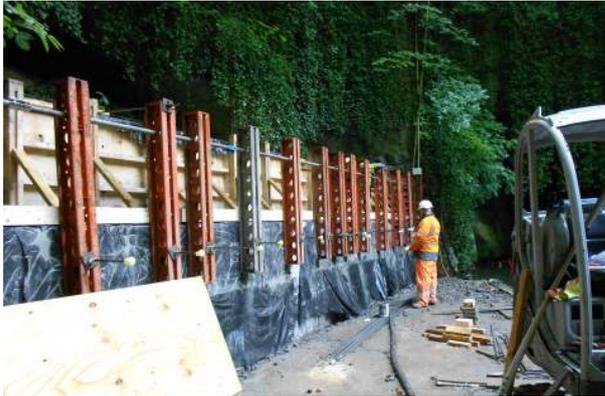
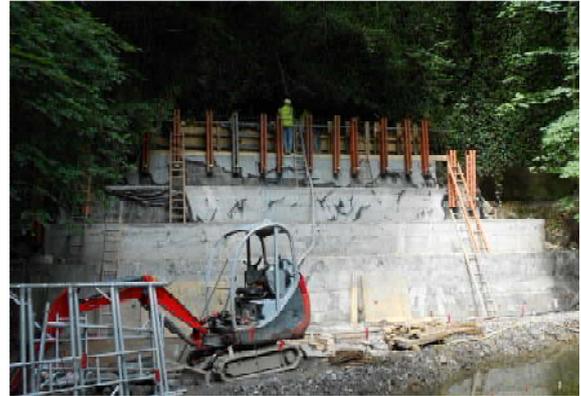
The canal basin is only accessible by canal boat from the Tipton Portal of the canal, adjacent to the Black Country Museum, passing through Lord Wards Tunnel and Shirts Mill Basin before reaching the worksite and therefore all plant and materials had to be transported on canal work boats through these small tunnels. The plant chosen was sized to suit this restriction including the use of a mini-excavator and mini-drilling rig.

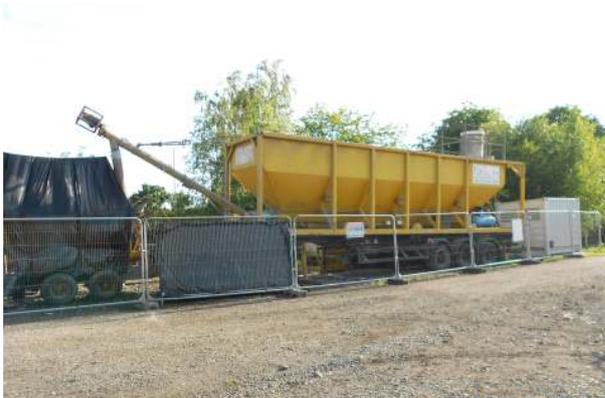
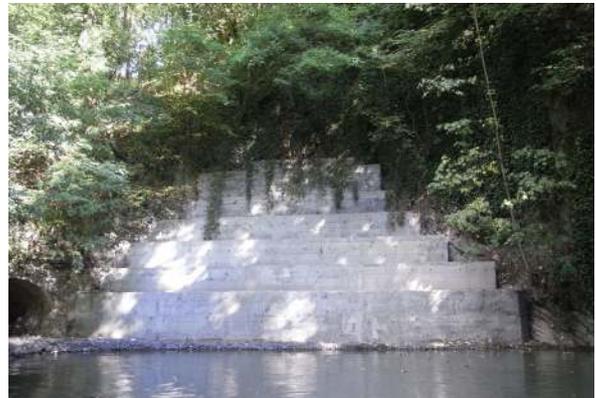
The cement based grout used to construct the retaining wall was mixed in the site compound adjacent to the canal tunnel portal and pumped approx 400m through the Lord Wards tunnel to Castle Mill basin. The 75mm HDPE grout was anchored to the timber rubbing board in the tunnel to ensure it could be monitored continuously during pumping. Extreme care was taken to ensure the grout delivery line was pressure tested and inspected before each use to ensure there was no grout spillage into the canal. Each lift of the wall required up to 25m<sup>3</sup> of grout.
