Walsall Arboretum Slope Stabilisation

Client: Willmott Dixon/Walsall Council

Designer: URS

Date: April—July 2014

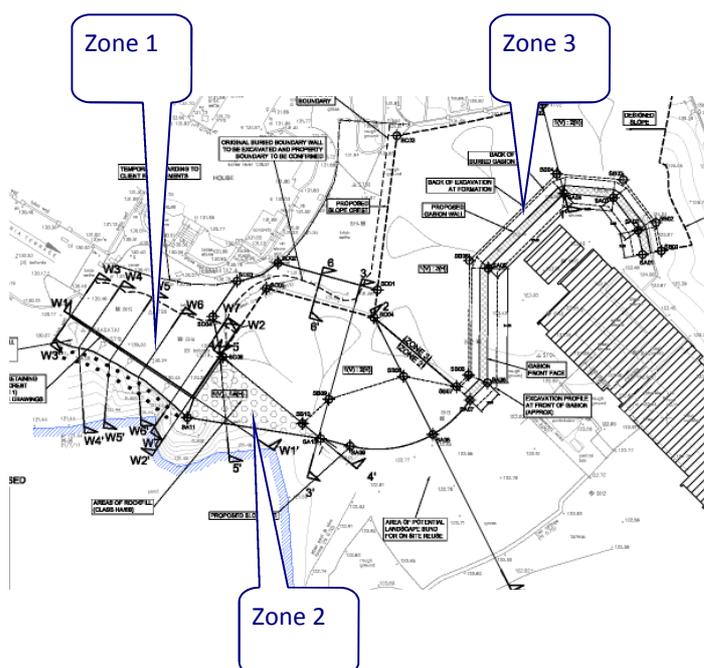
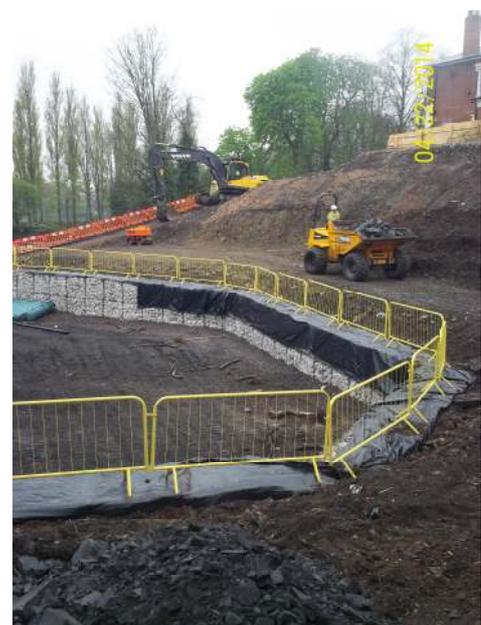
- **Zone 3**
 - ◇ Remove loose material and vegetation from the NE side of the embankment and create a compacted 6N foundation for the 44 lin m of gabion basket wall at the new embankment toe.
 - ◇ Compact imported 1A material in layers stepping into existing virgin material to form stable 1:2 batter 9m high.
 - ◇ Demolish boundary wall and private out buildings to construct 33 lin m of new brickwork wall and pillars.
 - ◇ Place topsoil to the new slope profile with biodegradable erosion control matting (1,000m²)

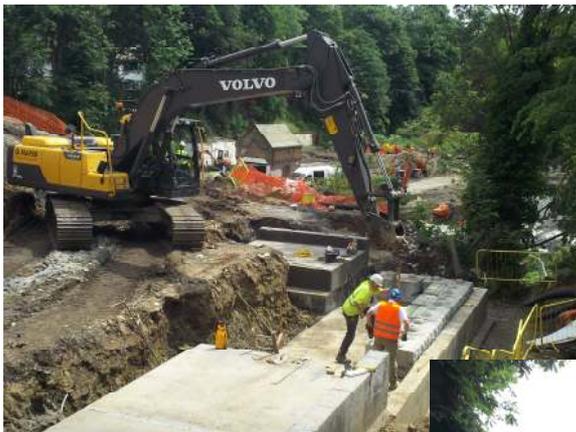
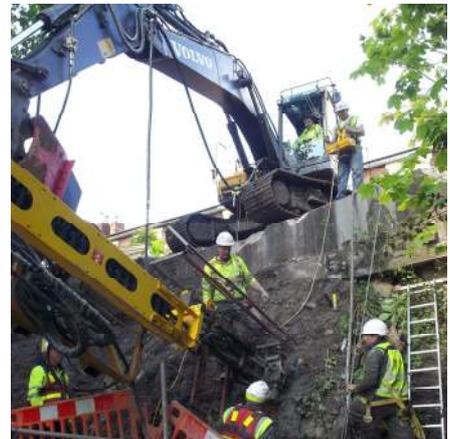
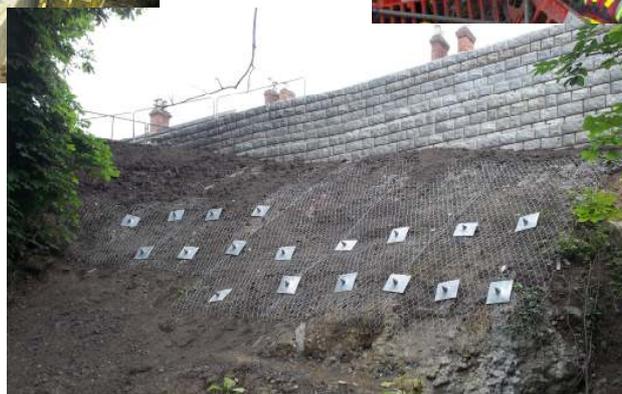
- ◇ Benched the excavated face above the lake to the south side of the new retaining wall and place 600t of 6B graded rock to a to form a 1:1.25 batter.
- ◇ Blind with 6N and remove access ramp creating 1:2 batter to new profile.
- ◇ Install outfall drainage pipework from the drainage layer at the rear of the retaining wall and also new surface water drainage
- ◇ Place 150mm topsoil and erosion control matting to 600m² of newly created safe slope.
