### Bream Land Stabilisation, Forest of Dean, Gloucestershire—Phases 1& 2

# **Project Profile**

Client: Gloucestershire County Council Designer: Halcrow Value: £1.01m

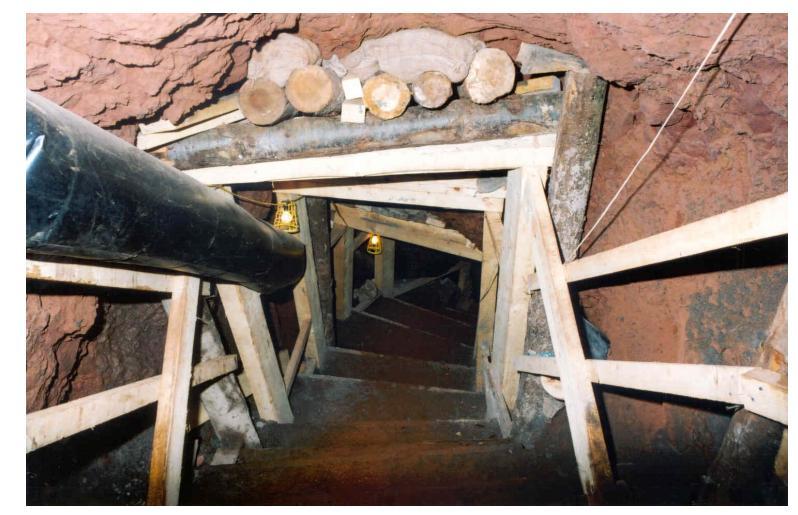
Access adit to Rough Winds Mine

This area required access to be made via an existing adit to the mine which was re-supported with timber frames. Continuous ventilation was required due to the recorded presence of (low levels of) radon. Personal monitors were carried to record exposure levels and working time was limited to 8 hours.

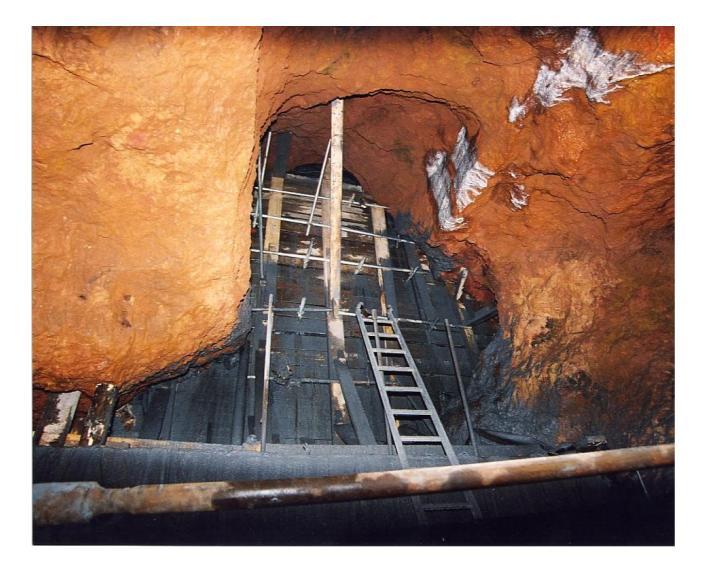
Shuttered barrier and grout infill area

Barriers to infill areas were created by using shuttering and filling with high strength grout. Barriers were stepped and raised in 1.2m lifts, using dowels drilled in the previous step to key-in-and support the next lift. Care was taken to prevent loss of grout into, or bursting of grout through discard by placing a geotextile membrane, onto the existing floor prior to grout filling.

Once the barriers had been completed and tied into the mine roof, the infilling of the (up-dip) galleries was carried out using PFA / cement grout ( $1700m^3$ ).

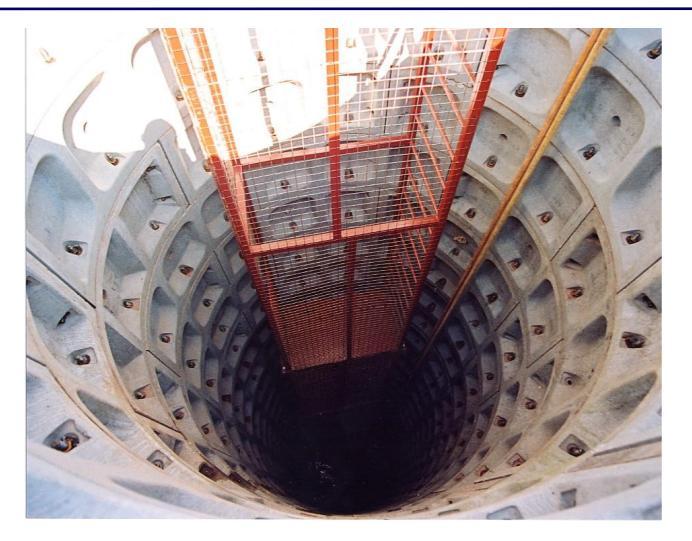
Access shaft to Brooklyn Mine

A number of site investigation holes were first drilled to accurately locate the Brooklyn mine then a new 18m deep x 2.4m diameter shaft was sunk onto a roadway to provide access to the Mine The shaft was constructed in the garden of the property 'Brooklyn' overlying the mine. Once access was gained, topographical, geotechnical, environmental and radon surveys were carried out.

On completion of infilling works the shaft was fitted with permanent ladder access and cover slab.

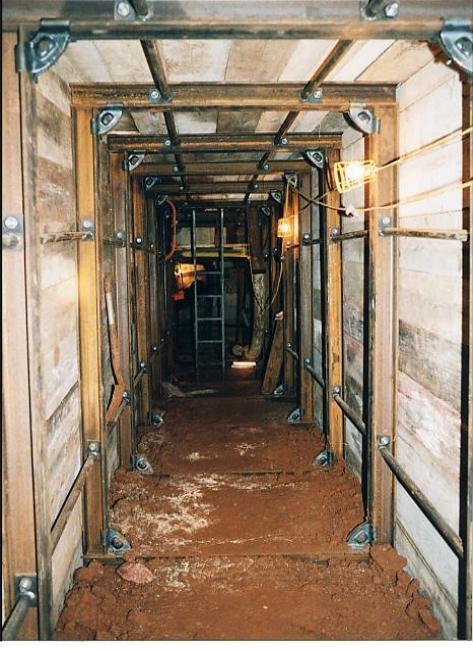
Permanent roadway through infilled mine

A section of permanent roadway was required to be left in place for drainage and for future access and monitoring to other mine areas. This was provided by lining an existing 20m section of mine roadway with standard mine arches, with bulkhead walls at each end formed from in-situ concrete, together with a structural concrete surround. 250m<sup>3</sup> of high strength concrete was pumped underground for this work.
