Northern Gallery Access Works & Seven Sisters Temporary Stone Infill.

Project Profile

Client: Dudley MBC

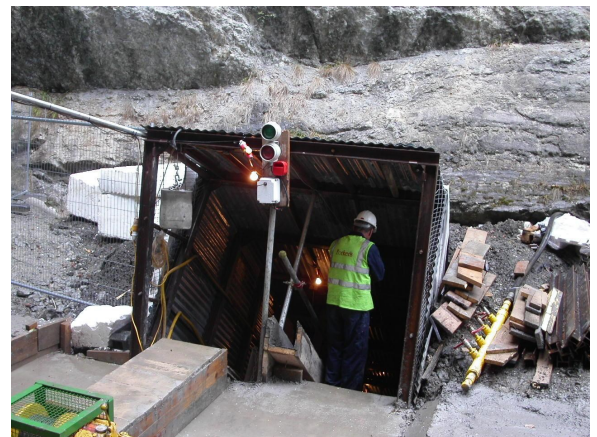
An anchored concrete working platform was constructed outside the potential area of collapse risk and guide rails lowered into the mouth of the gallery up to 38° angle of dip. This allowed sections of pre-fabricated steel tunnel to be lowered or 'slid' into the gallery.

Once this "outer" portal section of the tunnel was in place it was surrounded in concrete and then imported dolerite stone was placed over the tunnel and filled against the face of the exposed work face to provide stability and protection.

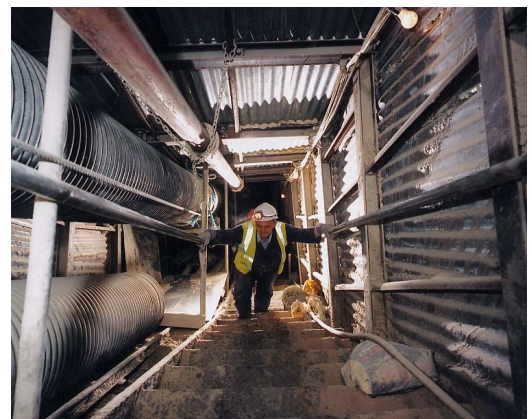
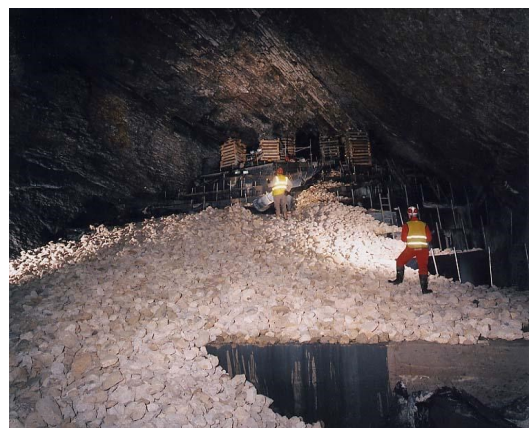
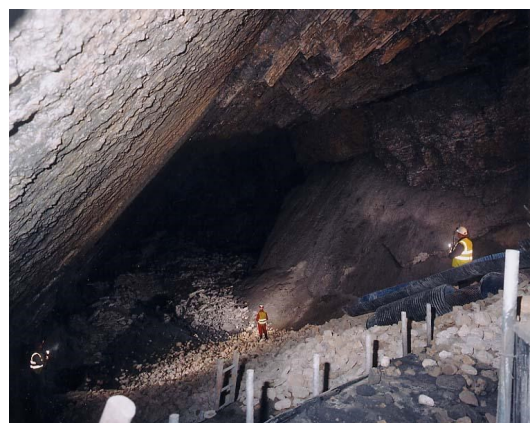
A barrier structure was then completed in the gallery to prevent infilling paste migrating from the Severn Sisters Gallery into the Northern Gallery area. The barrier, partially constructed against existing scree fill and partial in open upper areas was constructed in 13 steps over a height of 18m using 350m³ of foam concrete pumped into the mine from surface. Geotextile was used to prevent loss of foam concrete into the scree fill.

In order for the gallery to be fully utilized for a bat habitat, 600 tonnes of 150mm single size Jurassic limestone was imported and placed randomly down the slope of the gallery floor. To get this material into the gallery, a drop pipe and chute arrangement was constructed down the new tunnel, loaded by conveyor.

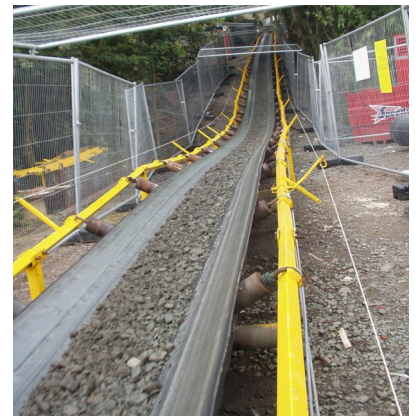
The Seven Sisters Upper Mine Gallery was to be filled above the level of the previously completed PFA paste infill of the lower mine areas by an inert and stable media that could be removed at a later stage, the chosen material was a 40mm crushed dolerite stone. The stone infill would allow positive internal support to the gallery roof and entrance pillars, reduce exposure to weathering and also would be clean and non-marking to ensure that the natural stone surfaces could be easily re-exposed. The mine gallery was classed as high risk and therefore had to be filled by non man entry methods.

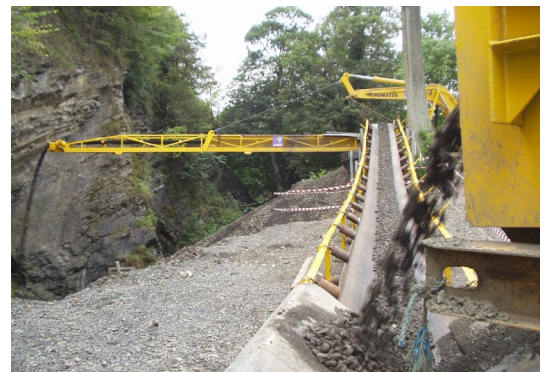
The surface access and dip of the gallery allowed the stone to be fed into the mine using a series of conveyors. An 80m long 65hp primary conveyor with 42" belt running from the compound area fed a 30m long secondary conveyor running parallel to the mine entrances. A series of 4 bridge belts between 6 and 15m long fed the stone into the gallery entrances allowing it to cascade down dip into the main gallery area thus allowing progressive infilling.

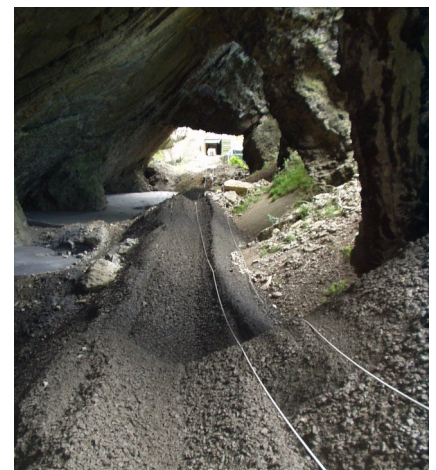
Once in the mine, the stone was distributed along the length of the gallery using a Joy-continuous miner "slusher" dragline type unit. The unit was resourced with 2 x 200m ropes allowing the drive and return units to be set up outside the high risk zone.

A total of 10,000 tonnes of stone was placed in the mine, with the final placement made by an excavator sitting outside the mine with a 6m long pushing arm to 'stow' the stone into the roof of the gallery entrances and trim the exposed faces.
