# Shrewsbury School Landslip

## Project Profile

**Client:** Shrewsbury School

**Designer:** Ramboll UK

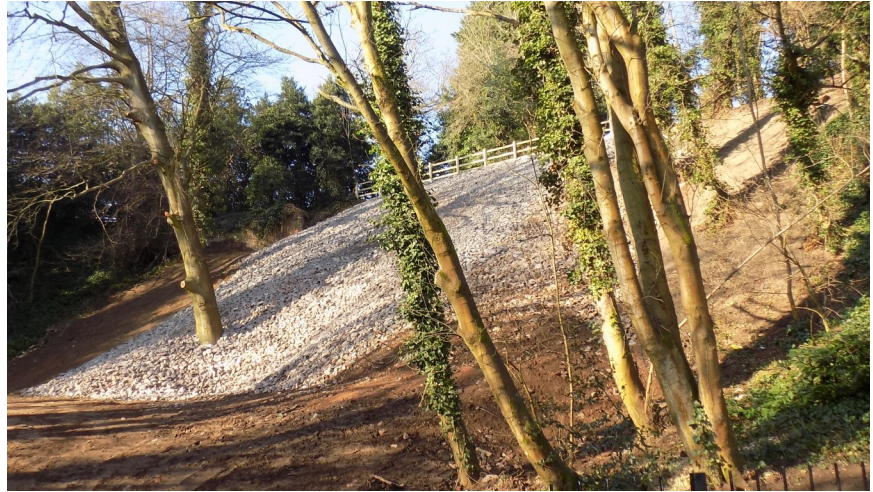
This contract was undertaken to remediate a landslip which had occurred to a steep river escarpment slope at Shrewsbury School, Shrewsbury. The steep, vegetated embankment within the ownership of the School failed following heavy rain in June 2018 when a section of retaining wall collapsed precipitating the landslip. The collapse caused damage to the adjacent Ridgemoor Lane, damaged existing services and felled a number of mature trees growing on the slope.

The top of the slope (Ridgemoor Lane) is elevated approximately 15 m above the River Severn flood plain land to the east on a slope graded at approximately 33 degrees (1 vertical to 1.5 horizontal). Prior to the failure, the upper part of the slope was supported by a brick retaining wall which substantially collapsed during the failure event, subsequent investigations suggested that the wall had no foundation. Because of the nature of the failure that occurred and the poor quality soils making up the slope the proposed solution comprised the construction of a free draining granular buttress made from imported stone/rockfill to stabilise the slope.

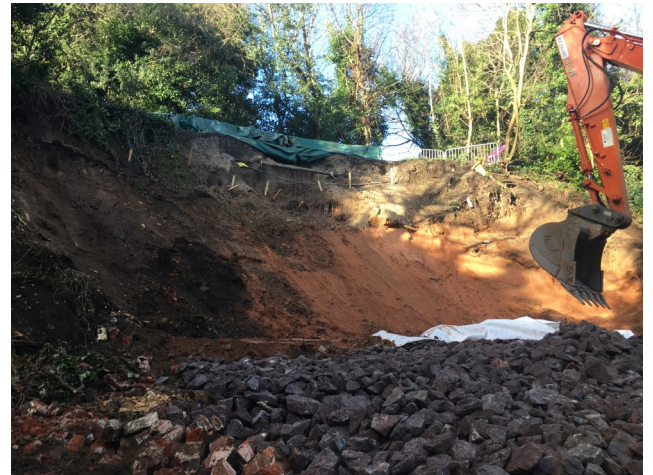
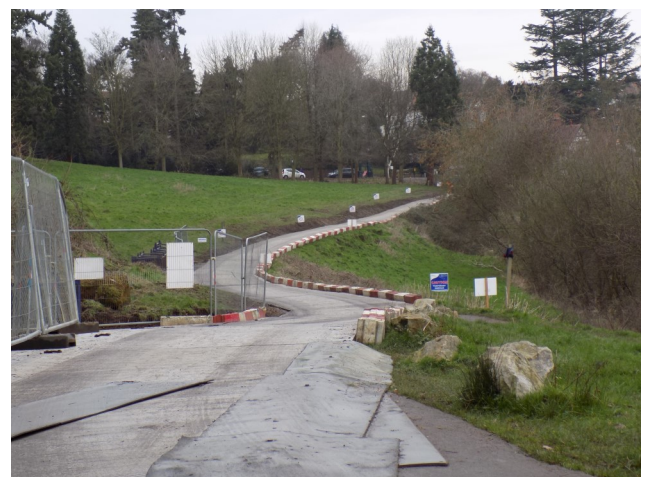
- Establishing a Japanese Knotweed exclusion zone around existing stands of vegetation.
- Vegetation and tree clearance at the base of the embankment and entrance to the riverside track to accommodate construction vehicles, provide protection for trees to be retained and form new wildlife habitats with felled trees and soils.
- Modify existing fencing at the entrance to the riverside track and take down existing removable section of boundary fence to improve turning off Porthill Road.
- The existing public access track alongside River Severn which was used by the Rowing club and others was widened using Trakway to accommodate construction plant and material delivery lorries and a hardstanding was also established at the base of the failed slope to accommodating delivery vehicles.

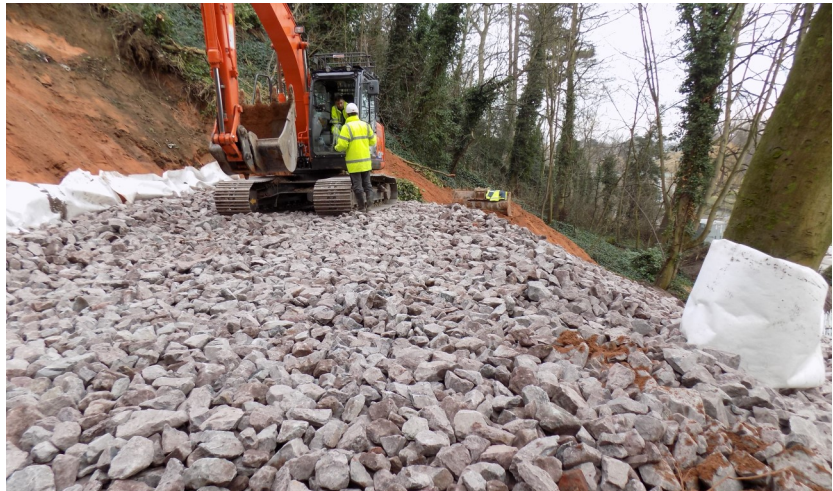
- The slipped material from base of embankment was disposed off-site.
- Import and stockpile Class 6B Stone for the buttress construction remedial works.

- Using a long reach excavator located at the base of the embankment to trim the existing failed slope material to form 2m high benches, place geotextile separator and place imported Class B stone to new slope angle— 2,163tonnes of stone used.

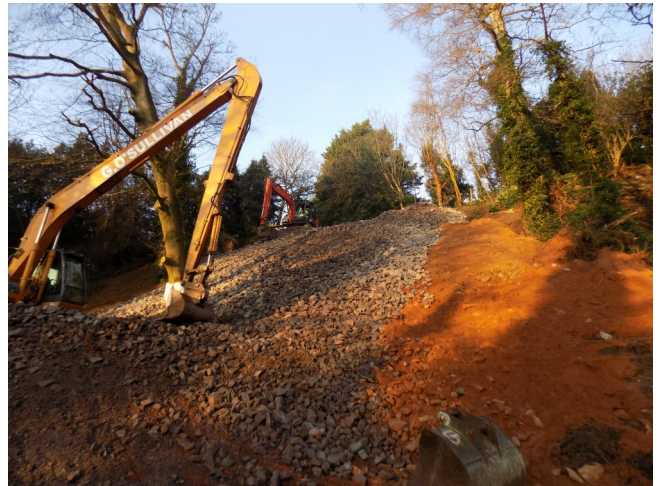
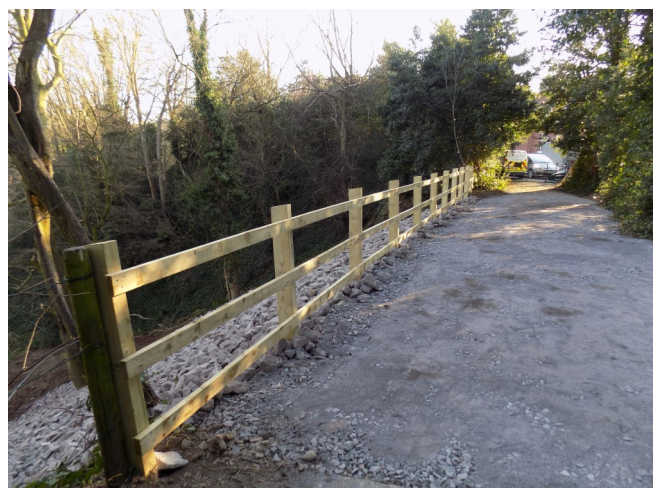
- The stone buttress was constructed by working in 5m width sections across the embankment and placing/compacting the stone in 600mm deep layers.
- Construction of the 15m wide buttress was completed across the full width at each bench level to ensure stability of the existing slope.

- A 13 tonne excavator worked up the slope placing and compacting the 6B stone to each platform before constructing the next level. The excavator exited the finished works via the top of the embankment upon completion.

- Reconstruct Ridgemount Lane at the top of the buttress construction, replace the surface water drainage and provide new fencing.
- Reinstate the Rowing Club access track and boundary fencing.
