## Northern Gallery Access Works & Seven Sisters Temporary Stone Infill

<b>Client:</b>	Dudley MBC
<b>Value:</b>	£770k
<b>Date:</b>	2003/2004
<b>Type of Mine:</b>	Limestone

### 1. Northern Gallery access works

### 2. Infilling of Upper Seven Sisters Gallery with Temporary Stone Infill

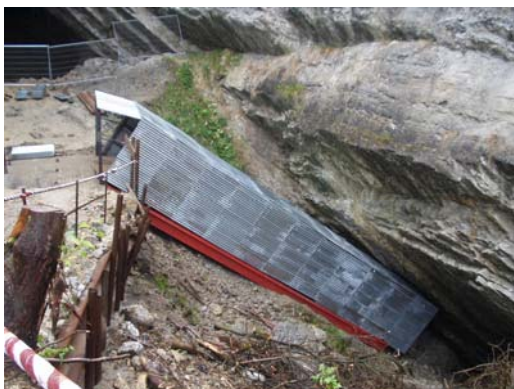
Tunnel portal section prior to filling over

An anchored concrete working platform was constructed outside the potential area of collapse risk and guide rails lowered into the mouth of the gallery up to 38° angle of dip. This allowed sections of pre-fabricated steel tunnel to be lowered or 'slid' into the gallery.

Once this "outer" portal section of the tunnel was in place it was surrounded in concrete and then imported dolerite stone was placed over the tunnel and filled against the face of the exposed work face to provide stability and protection.

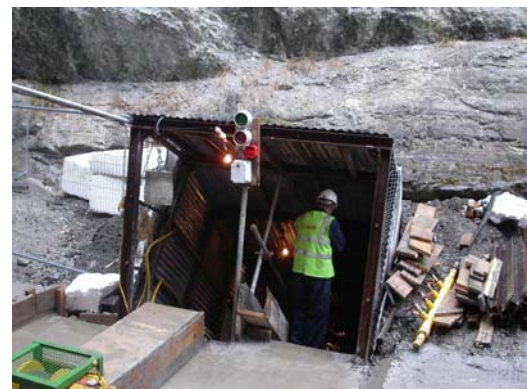
View of tunnel portal

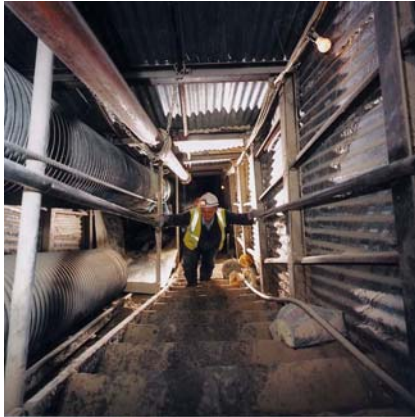
View down completed tunnel

Once portal works were completed the new tunnel was driven through collapsed and backfilled material into the Northern Gallery finished at the top of the scree pile. A bulkhead wall was formed around the end of the tunnel and the tunnel surrounded in concrete.

The tunnel is 40m long and driven down dip at an angle of 38°. Frames were set at 1.2m and bolted to the mine roof.

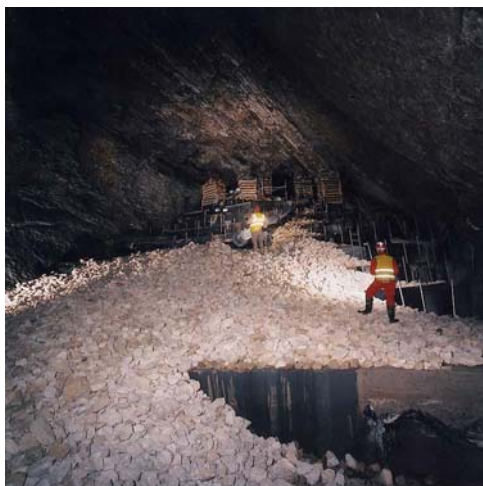
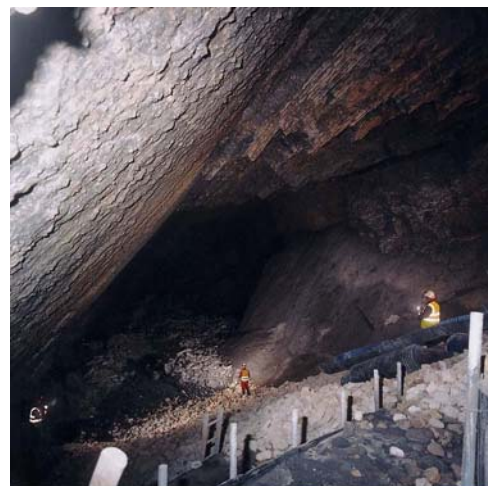
In order for the gallery to be fully utilized for a bat habitat, 600 tonnes of 150mm Jurassic limestone was imported and placed randomly down the slope of the gallery floor. To get this material into the gallery, a drop pipe and chute arrangement was constructed down the new tunnel, loaded by conveyor. This work was carried out in close liaison with Bat specialist – Dr Robert Stebbings Consultancy.

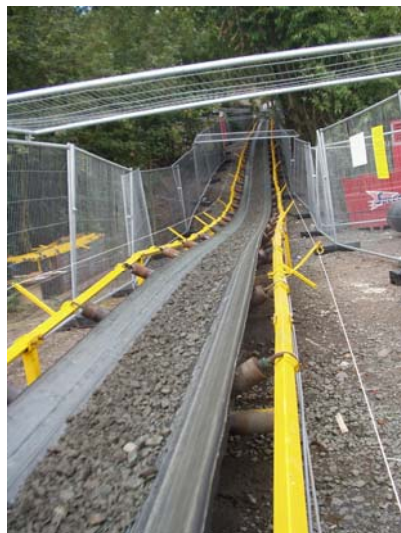
Primary Conveyor

An 80m long 65hp primary conveyor with 42" belt running from the compound area fed a 30m long secondary conveyor running parallel to the mine entrances. A series of 4 bridge belts between 6 and 15m long fed the stone into the gallery.

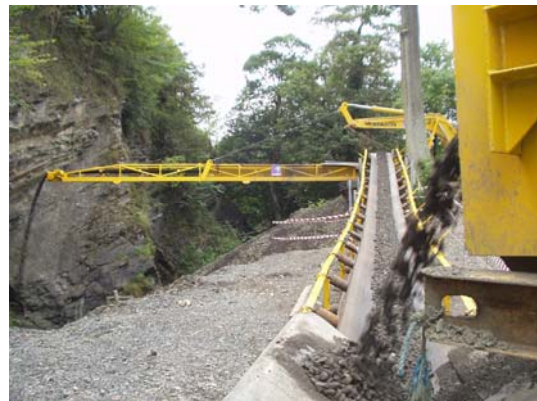
Secondary belt with bridge belt

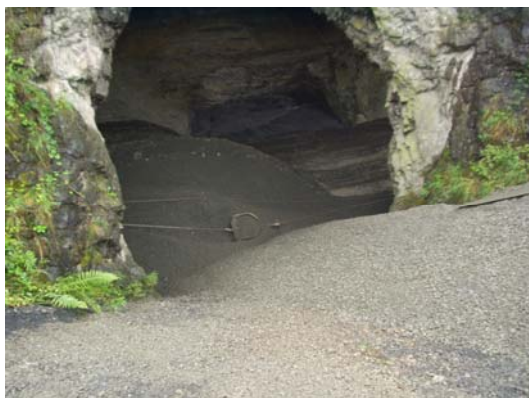
'Slusher' distributing infill stone

Once in the mine, the stone was distributed and stored using a Joy-continuous miner "slusher" dragline type unit. The unit was resourced with 2 x 200m ropes allowing the drive and return units to be set up outside the high risk zone.

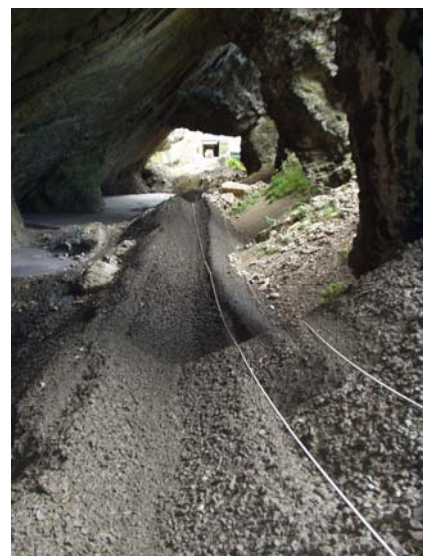
View through gallery at start of stone infilling
