## James Adams Mine (Remainder) Stage III Treatment

Client	-	Walsall M B C (English Partnerships)
Engineer	-	Johnson Poole & Bloomer
Value	-	£2.5m
Completion	-	November 1998

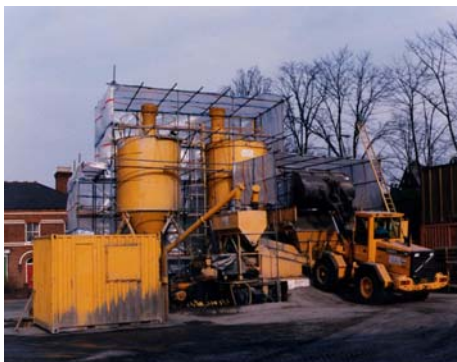
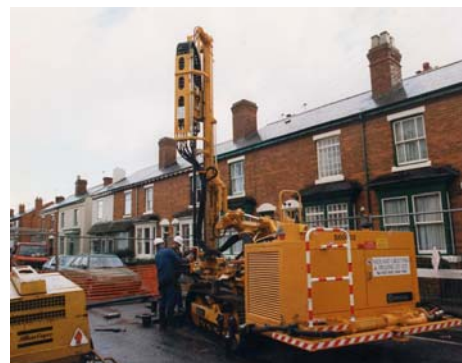
Grout mixing was undertaken using computer controlled continuous grout batching plant with mixed grout pumped to a mobile agitation / pumping unit situated at the treatment area.

- PFA storage and mixing plant area, container surrounded with overhead spray bars for PFA damping.
- Mixing plant additionally screened and covered to ensure no dust generation.
- Drive through wheelwash provided.

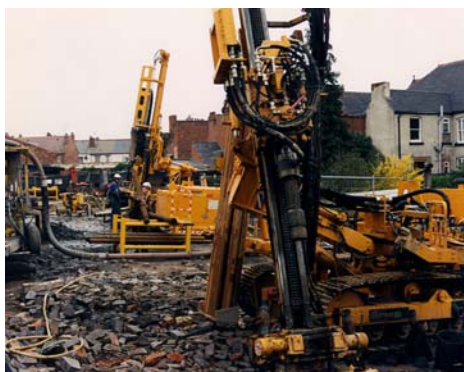
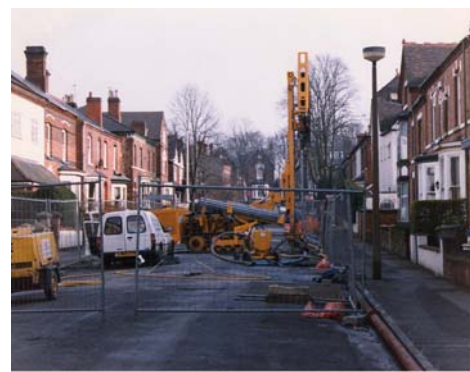
- Water flush drilling with cuttings collected at drill hole and pumped to settlement tanks in compound.
- Continuous liaison and planning with Engineer and Client regarding sequencing the works and positioning of drill holes, pipelines and grouting plant, maximising use of angled drilling from protected locations and minimising entry to highways and garden areas, thus limiting disruption, reinstatements and impact of the work.
