## Wrens Nest Area 14/16 and Castle Hill West Area 21/22 Abandoned Mine Infilling

<b>Client</b>	Dudley Metropolitan Borough Council (funded by English Partnerships Land Stabilisation Programme)
<b>Value</b>	£ 3,200,000
<b>Completion</b>	December 1998

Work involved bulk infilling, grouting and underground work to stabilise redundant limestone mine workings, in two areas of approximately 15 ha. of residential, open space, roads and canals.

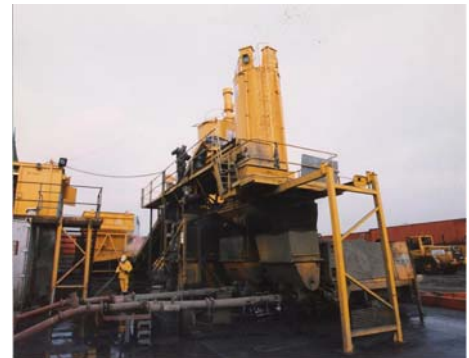
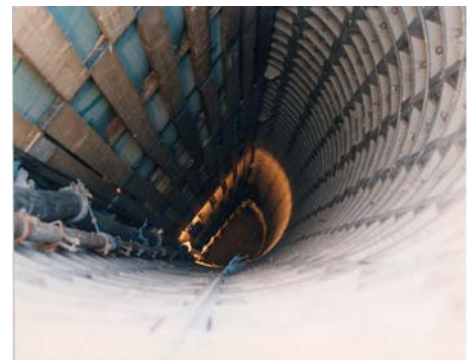
The infill paste and grout was mixed using computer controlled continuous mixing plant of 130m<sup>3</sup> per hour capacity and pumped using high output trailer mounted concrete pumps. For pumping distances in excess of 1500m, a stage pumping station was established with 10m<sup>3</sup> capacity holding agitator, with matched concrete pumps to re-pump to paste injection points. Grout was similarly pumped to a 7m<sup>3</sup> mobile agitator/pump unit, from where it was pumped to injection point.

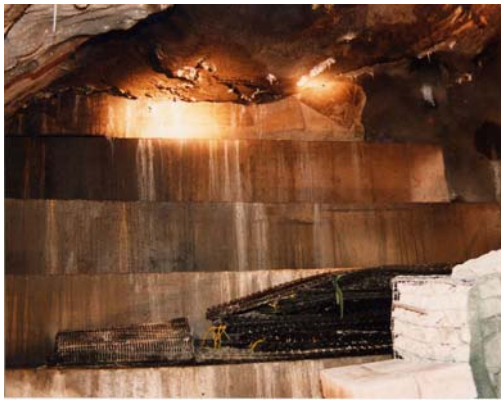
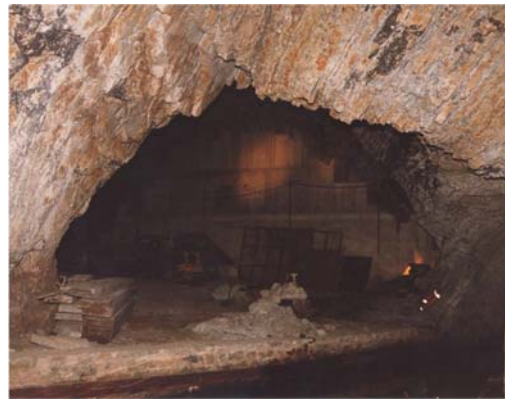
Access to the barrier works in Little Tess and Hurst Cavern were via the existing operational canal system requiring agreement of timetables, methods, emergency procedures and safety systems with Dudley Canal Trust, who continued to use the canal system for tourist trips. Generally barriers were constructed using in-situ reinforced concrete with sacrificial blockwork back shuttering. Concrete was pumped from surface through purpose drilled and cased holes at barrier positions.

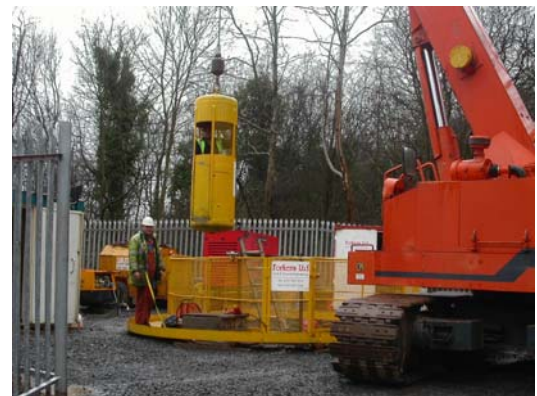
Forkers have carried out enabling works, establishment of decking, accesses and walkways within the canal basin and mine galleries, provision of supervision and attendance, establishment of monitoring equipment, security, emergency facilities, craneage and manrider access, and lighting to shaft and underground areas. These works have been carried out under MASHAM Regs under the supervision of Dudley MBC’s Mine Manager Mr Ken Leach. Surveys have been carried out both by visual inspection and laser survey equipment to calculate the gallery volumes.

Following completion of the main infilling scheme, the new access shaft – ‘Step Shaft’ - has been re-opened on a number of occasions for ongoing safety inspection and survey work to the disused mines canal system and a number of other unfilled galleries in the Wrens Nest mines system, in particular the Step Shaft Gallery, an 80m long x 20m high x 10 wide gallery in a near vertical seam of limestone.
