Field Road/Coley District: Phase 3 Chalk Mine Ground Investigation and Ground Stabilisation Scheme

Client: Reading Borough Council
Designer: Peter Brett Associates (PBA)
Project Manager: SLR Consulting
Value: £3.3m
Date: Jan – Dec 2011

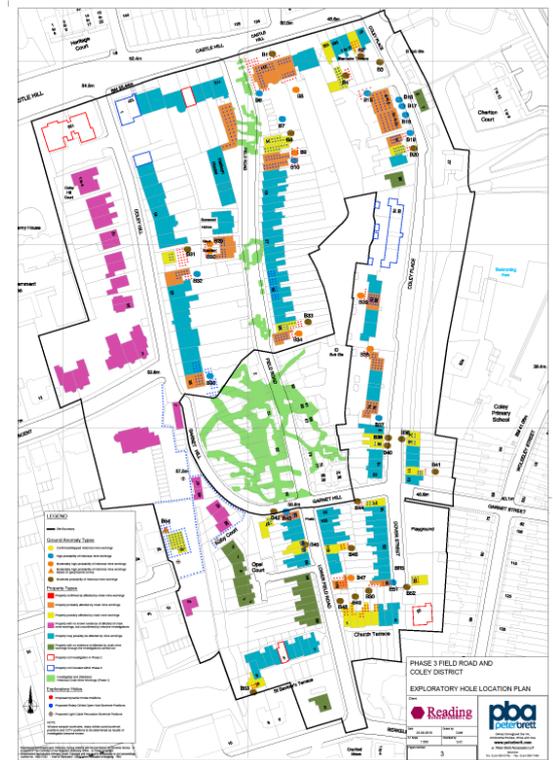
Interpretation of data from the previous investigations had identified at least 17 areas of workings and a priority investigation and treatment sequence was allocated by PBA to groups of properties or individual houses for this scheme. This drawing shows the location of investigation holes, and the results from these holes were analysed to enable design of the stabilisation solution which is bespoke to each property.

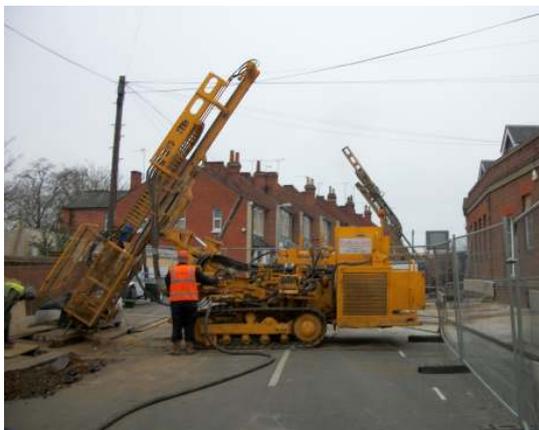
We used inclined drilling techniques for much of the drilling under the properties so we could carry out the work from roads, gardens and courtyards around the buildings, rather than carry out any of the work from inside properties which would have been immensely disruptive, and we used several rig types to ensure we could cope with the varied access restrictions.

Drilling rigs used in the investigation phase included Klemm KR904 geotechnical rigs, Klemm KR701 and Krupp 30G Mini rigs as well as Terrier dynamic probe rigs.

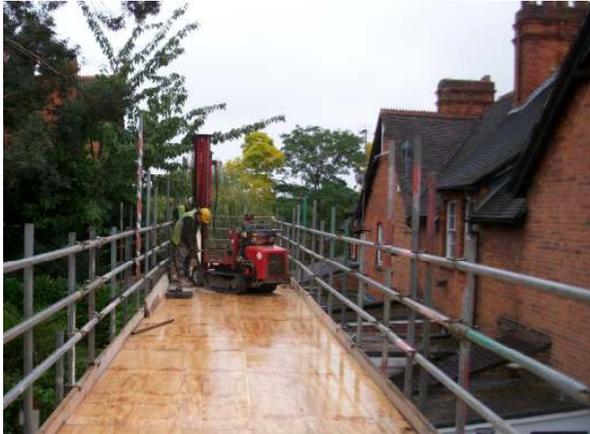
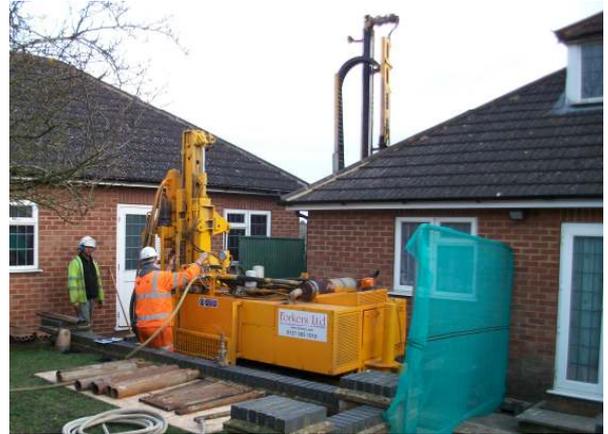
During rotary investigation drilling various parameters were recorded including rotation speeds, air pressures, penetration rates and flush returns which gave Peter Brett engineers a clear indication of ground conditions and the presence of mining anomalies.

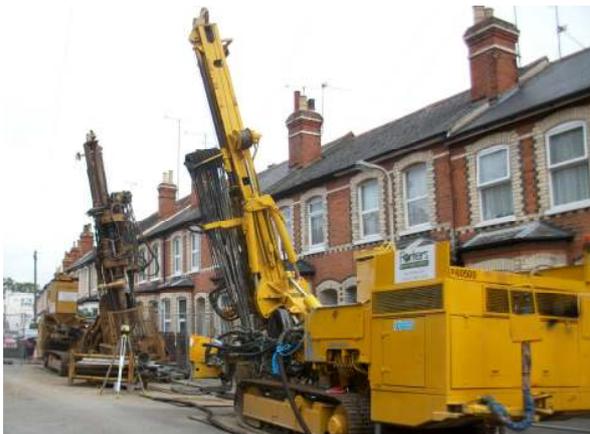
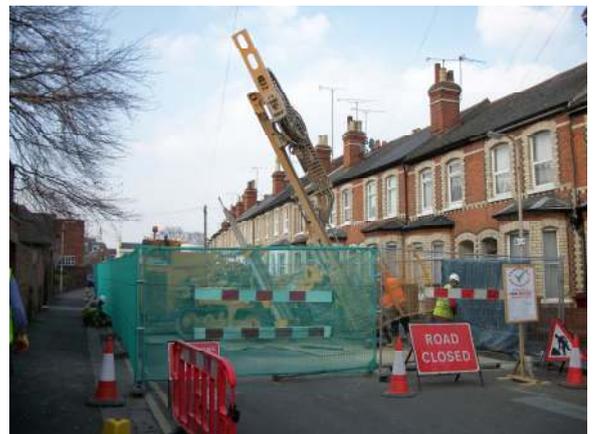
The investigations revealed 20 mine workings which were treated by either infilling the larger voids with a 5:1 PFA/cement infill grout or stabilising macro voided, loosely infilled or collapsed areas using compaction grouting techniques. Here a 6:2:1:0.1 mix of sand, PFA, cement and bentonite was injected using an 'end of casing' injection method, 101/139mm diameter rotary/rotary percussive steel casing was drilled to the full hole depth and then used as the grout injection tube, the casing was withdrawn in stages thus allowing complete control and monitoring of grout volumes and pressures. 1700 tonnes of grout was injected during the treatment phase.

555 treatment holes were drilled predominantly by angled drilling to target treatment of the property footprints. Drilling rigs used during the treatment phase included Klemm KR904 and Casagrande C6S geotechnical drill rigs, Klemm KR701 and Krupp 30G Mini rigs.
